# Brown's Home Inspections Ltd. (License # 352839)

## Home Inspection Report

**Edmonton, AB**

Inspected on Wed, Nov 17 2021 at 1:30 PM

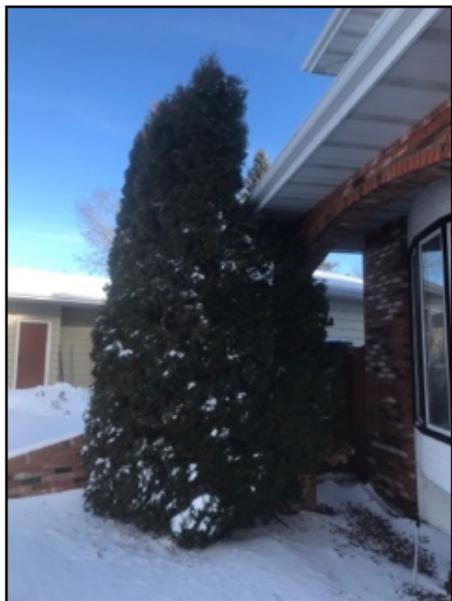
Figure 1-1

Vegetation is growing against the structure which can cause premature wear and tear against the structural building and roof. Recommend the bushes be trimmed back from the structure.

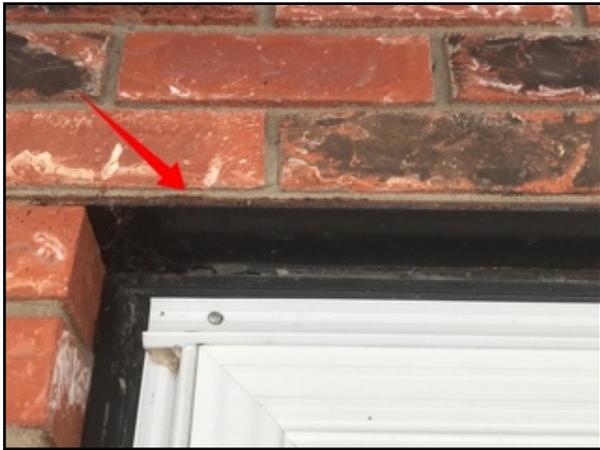
Figure 9-1

The metal lintel above the front door and garage door is starting to rust; recommend painting to prevent just from occurring and compromising the steel lintels.

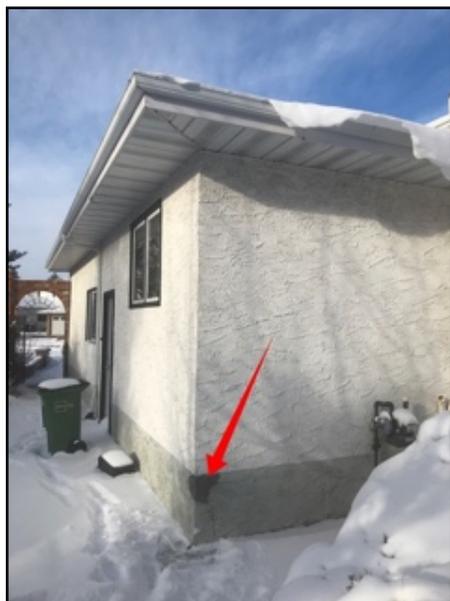
Figure 11-1

The se corner of the garage has had repair to it. There is a hole right below where the footing should be which suggests there can be structural movement below. Some repair has been attempted but it has not held together; recommend further proper repair.

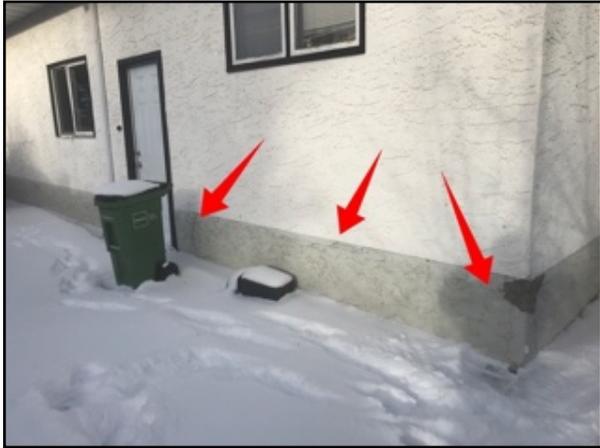
Figure 13-1

**Comment 13:**  
I have provided a sample of the cracks in the parging around the house;  
recommend repair of the parging to prevent moisture intrusion.

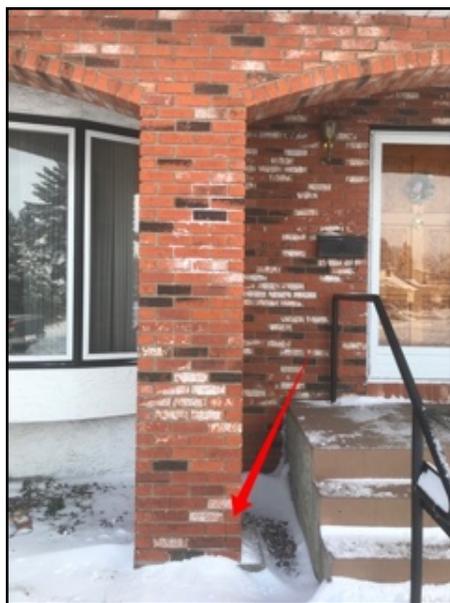
Figure 15-1

Minor separating the brick and mortar cracking on the pillar to the left of the front door; recommend repair to prevent further damage.

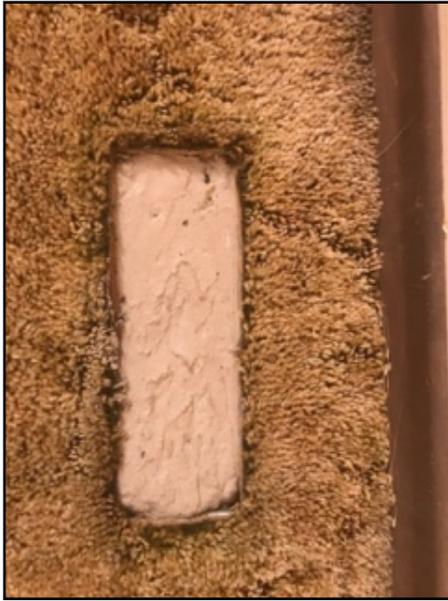
Figure 18-1

The in floor furnace ducting has been filled in with concrete except for one register. Upon inspection of the register there is rust in the bottom of it and active water (wet on my hand) present within the ducting. I believe there is a moisture problem under the slab as there is no weeping system. I believe that the water has infiltrated the ducting which is why they filled it in instead of installing a proper weeping system.

I have obtained images from within the old furnace cavity which shows the filled in concrete block and the fact that the flooring vents were 3/4 full of water at some point in time which has caused all of the rust seen in the images.

Recommend asking the home owner for more information.

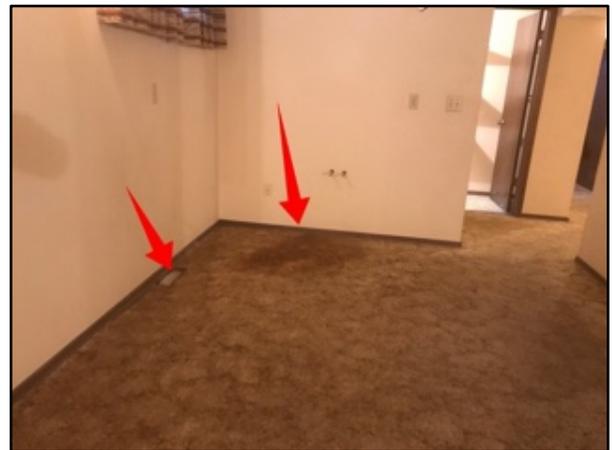
Figure 21-2

Comment 21:  
Staining throughout.

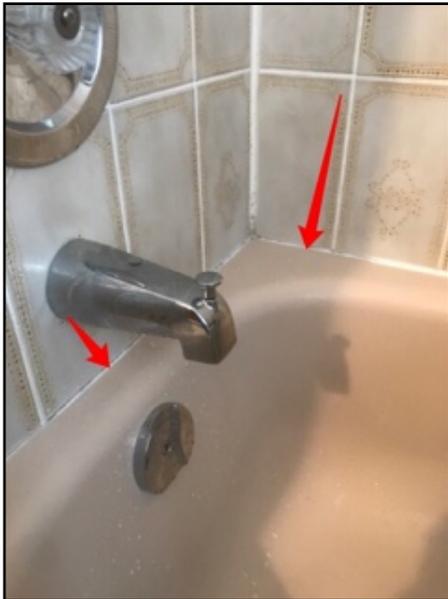
Figure 29-1

The caulking needs to be repaired to prevent moisture damage.

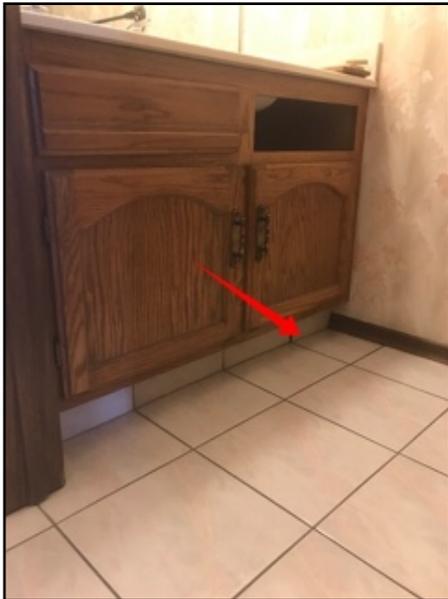
Figure 34-1

The tile is loose and coming off of the bottom of the cabinet.

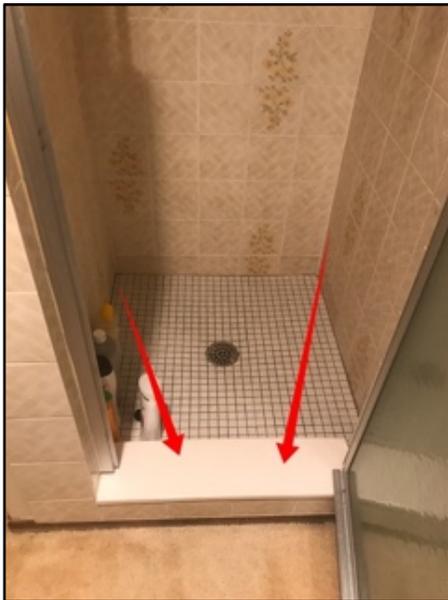
Figure 37-1

The shower threshold is loose and needs to be repaired.

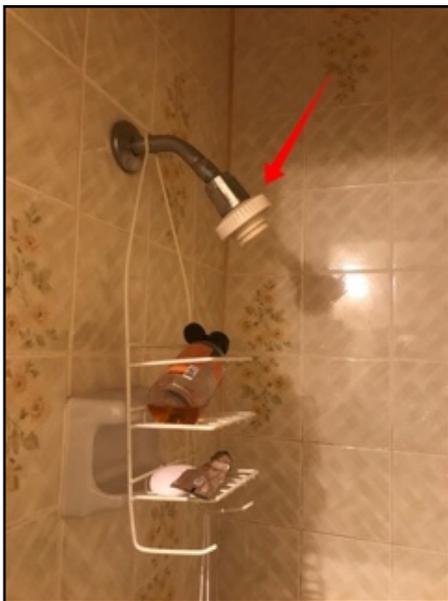
Figure 39-1

**Comment 39:**  
The shower head drips when not in use; recommend replacement.

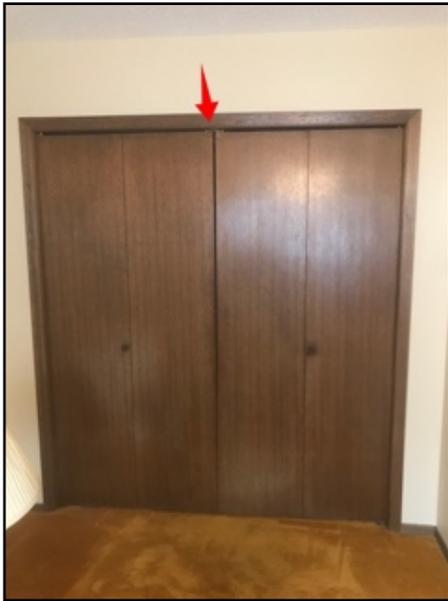
Figure 48-1

Comment 48:  
Broken mechanism and won't close properly.

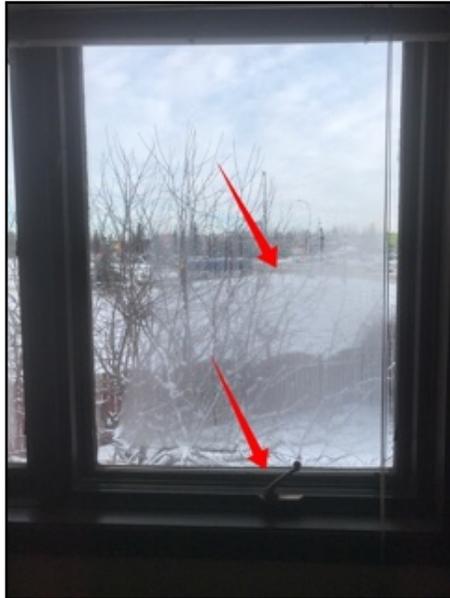
Figure 52-1

There is visible moisture on the windows and the window doesn't open and close properly; do not operate. There is a visible and Audible air gap.

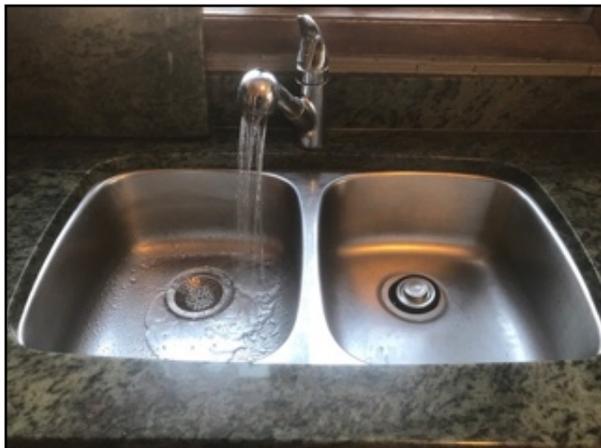
Figure 57-1

Very weak water pressure and the tap can't be switched between spray and constant flow; recommend replacement of faucet.

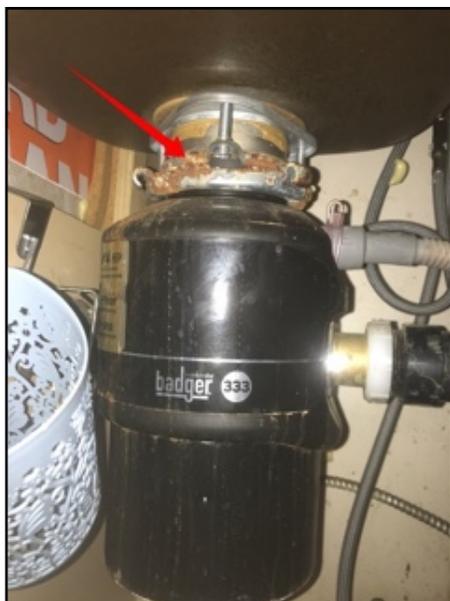
Figure 58-1

There is excessive rust on the top mount of the garbage disposal which suggests that there is a leak at some point in time.

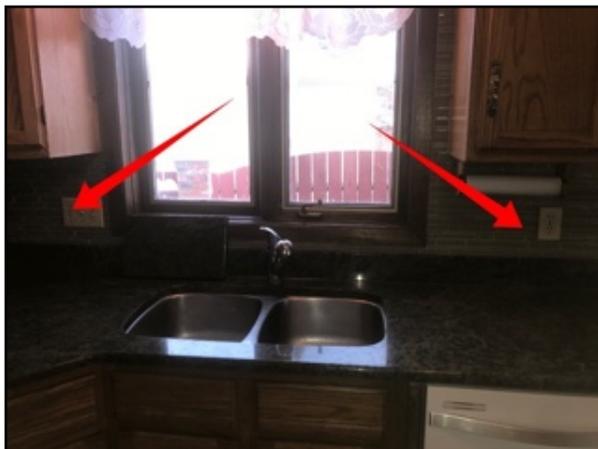
Figure 60-1

The counter plugs in the kitchen are within 6' of an open water source and must be gfcI protected to prevent electrical shock; recommend replacement.

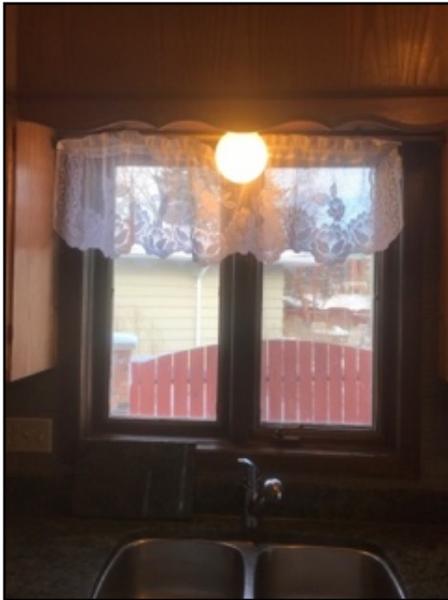
Figure 62-1

The kitchen window does not open and close smoothly; recommend repair or replacement.

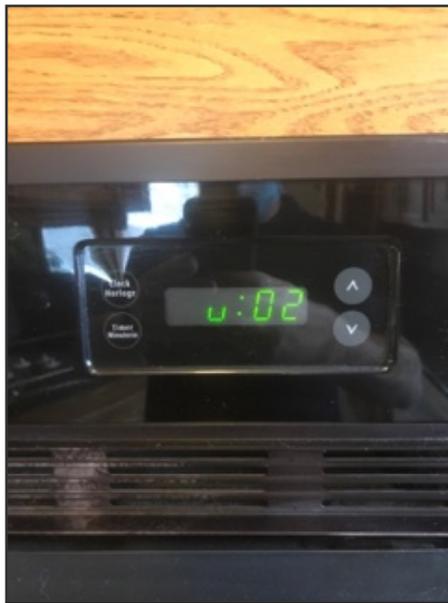
Figure 63-1

Comment 63:  
The digital display is broken .

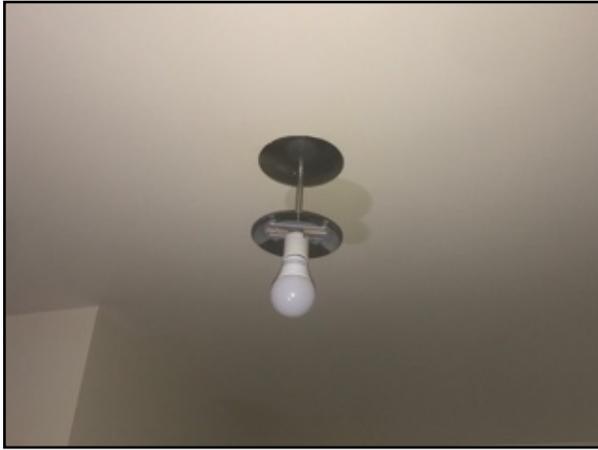
Figure 74-1

The light is either burnt out or not working.

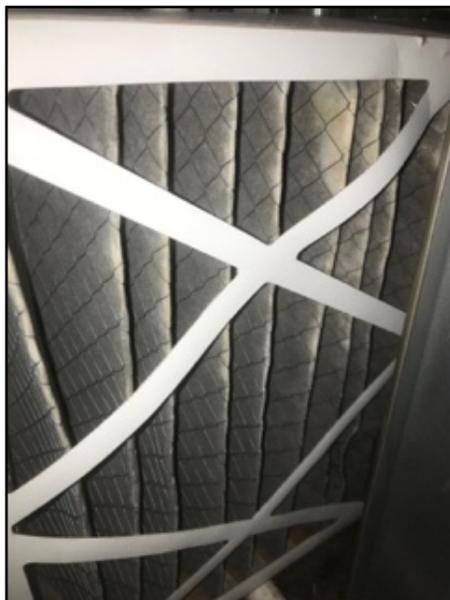
Figure 81-1

Filter needs to be replaced.

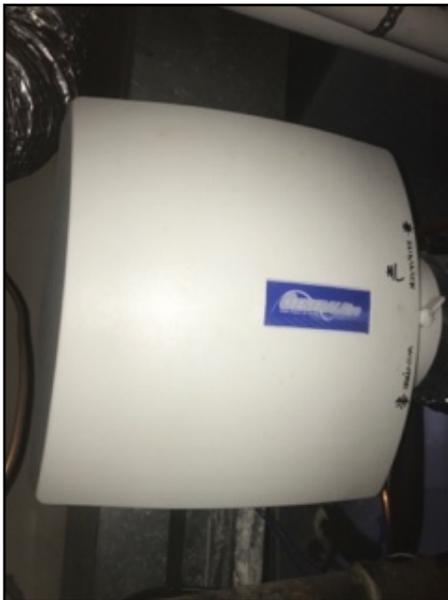
Figure 82-1

There was no water flowing to the humidifier during operation.

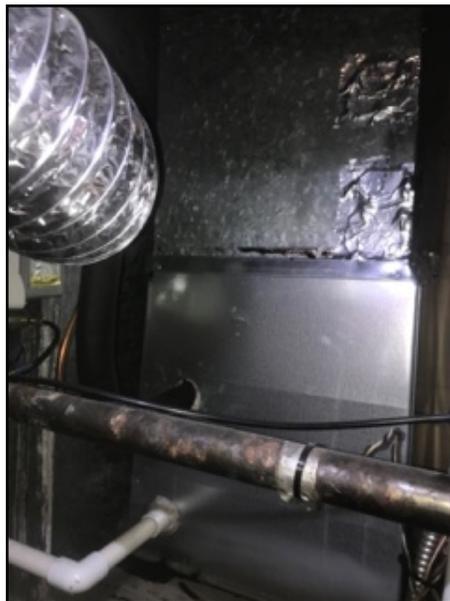
Figure 84-1

Comment 84:  
No data plate sticker was visible.

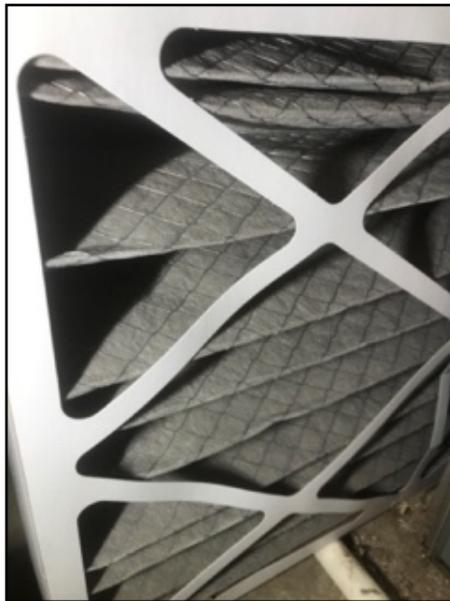
Figure 86-1

Comment 86:  
The filter needs to be replaced.

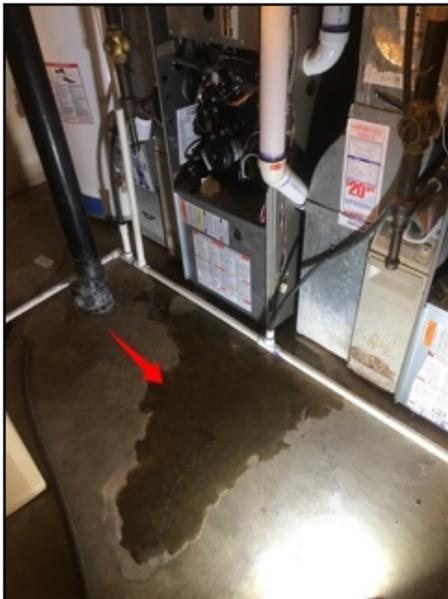
Figure 87-1

There is an active water leak; recommend repair.

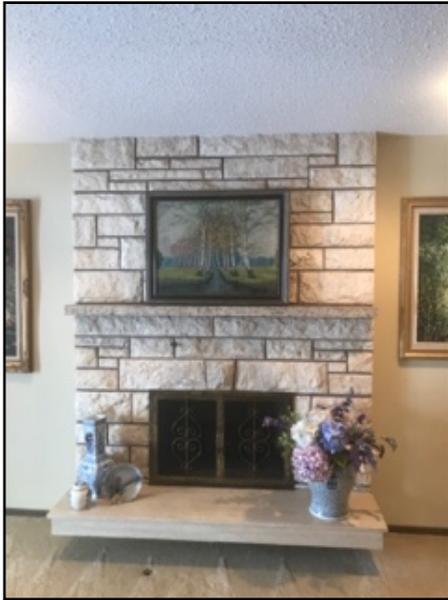
Figure 94-1

The fireplace looks lightly used. The gas assist has been disconnected and the flue on the inside isn't working properly and won't close properly high is sucking all of the interior heat up and out the chimney (this can be seen in the FLIR image which was obtained showing the cold cavity). Recommend a WETT certified inspection and repair.

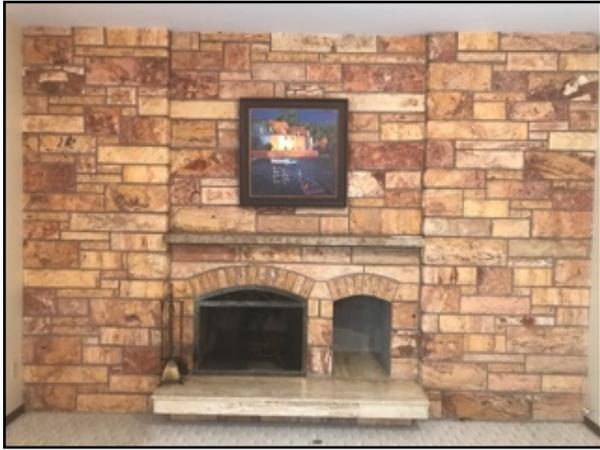
The flue does not open as it is rusted shut; do not use this fireplace. Recommend a WETT certified inspection and cleaning as the fireplace has soot build up.

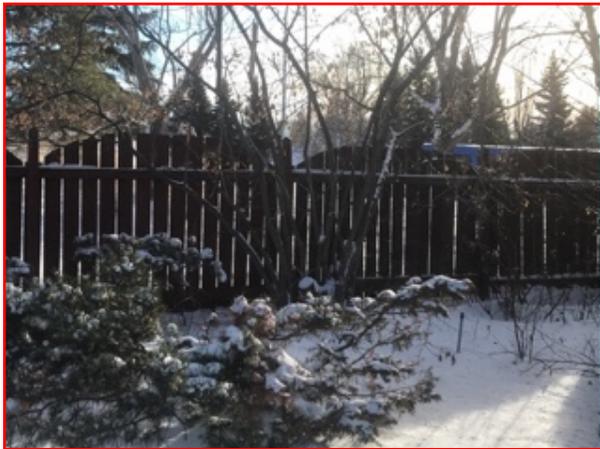
Figure 2-1

2) Comment 2: The fence is near its end of its life. There are brick columns near falling over if pushed on and there are sections of wood that are in need of repair.

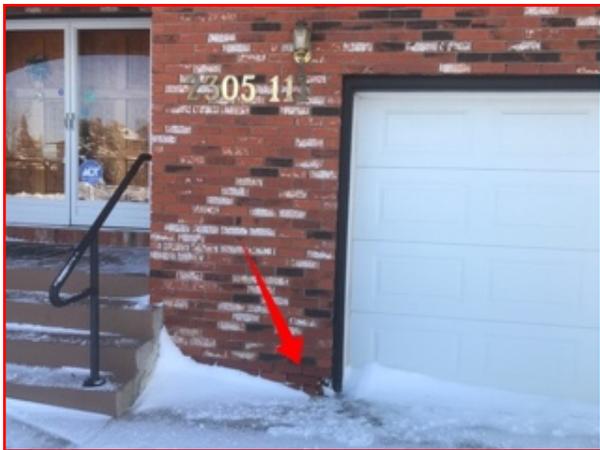
Figure 3-1

3) Comment 3: The brick on the house is a veneer however it is very heavy. The bottom left and bottom right and above the garage door has started to crumble and is missing bricks in spot. This needs to be repairs immediately to prevent moisture intrusion, further spalling and separation of the brick veneer.

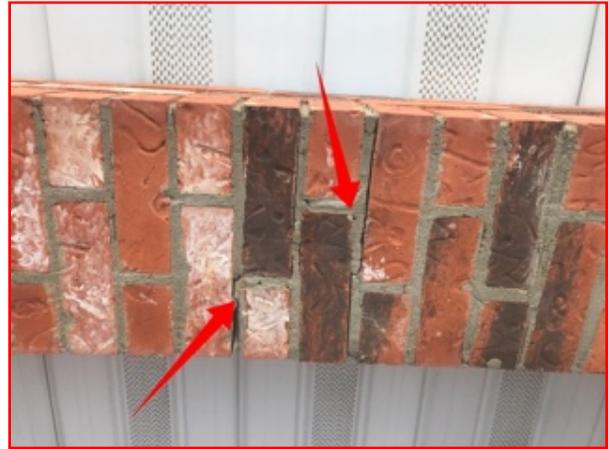
Figure 4-2

4) Comment 4: The keystone brick is loose in the Center; this holds the entire arch together. Without this properly sound the brick can fall out injuring someone and cause a collapse of the arc; recommend immediate repair.

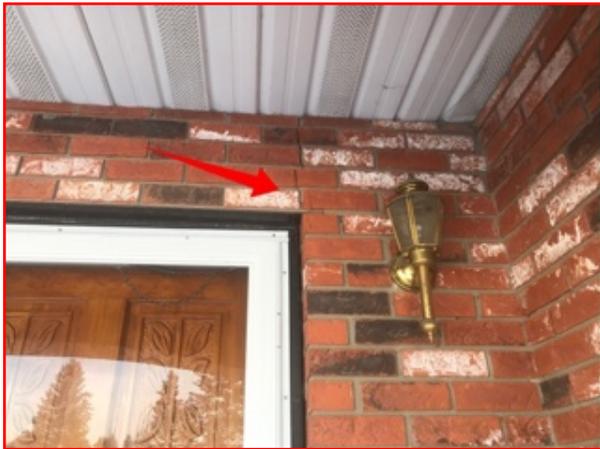
Figure 5-1

5) Comment 5: The brick to the upper right of the door has cracked through the brick and not around the brick in the mortar joint; this indicates a structural shift in the brick veneer; recommend repair from a brick mason.

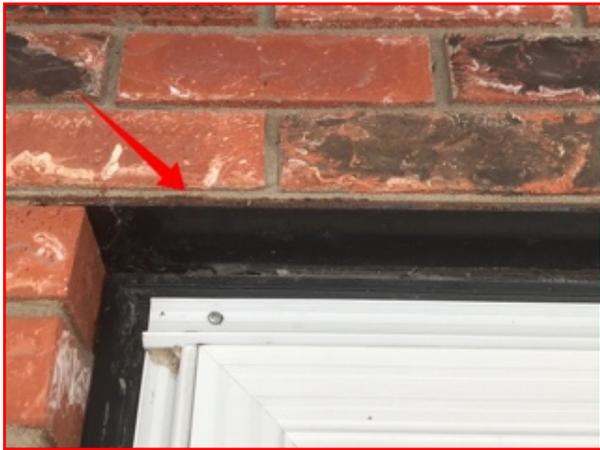
Figure 9-1

8) Comment 9: The metal lintel above the front door and garage door is starting to rust; recommend painting to prevent just from occurring and compromising the steel lintils.

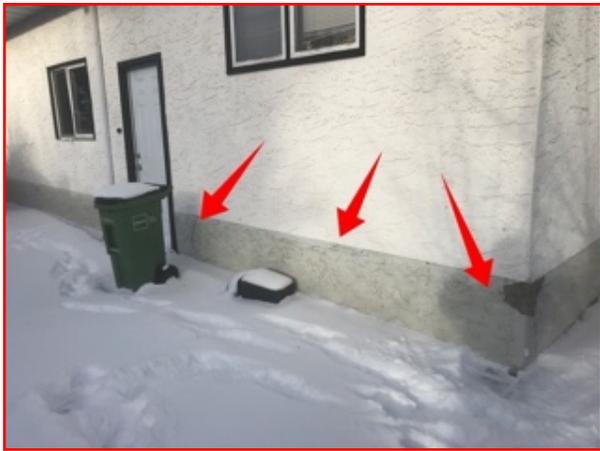
Figure 13-1

12) Comment 13: I have provided a sample of the cracks in the parging around the house; recommend repair of the parging to prevent moisture intrusion.

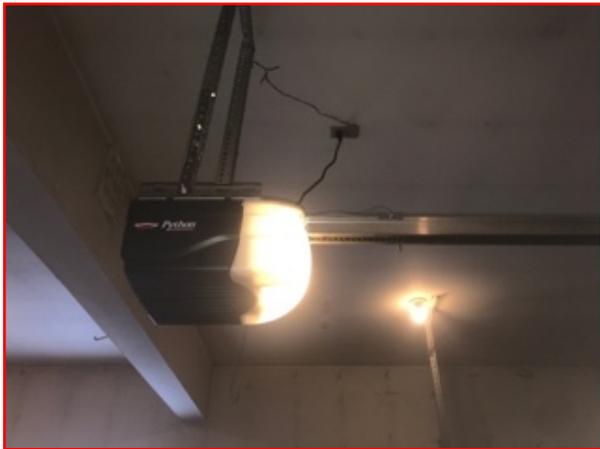
Figure 16-1

15) Comment 16: The pressure safety feature on the garage door opener does not work; recommend correcting as it is a safety issue.

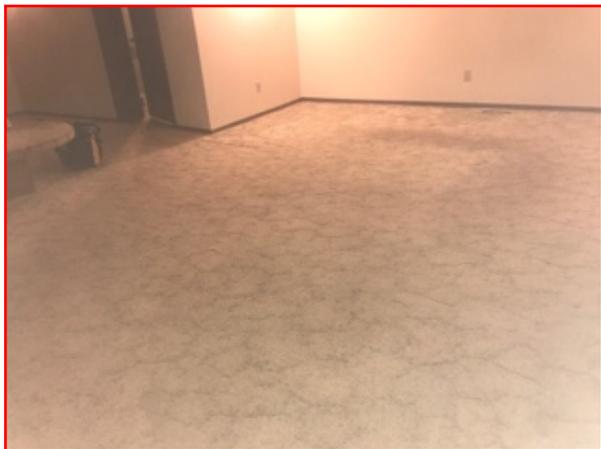
Figure 21-1

19) Comment 21: Staining throughout.

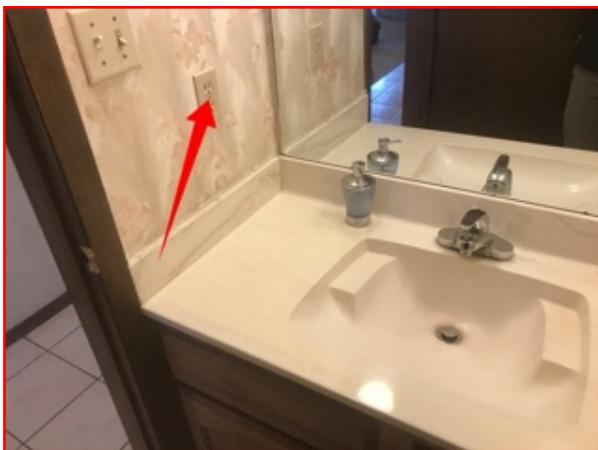
Figure 35-1

30) Comment 35: The counter plug is within 6' of an open water source and must be gfcı protected to prevent electrical shock; recommend replacement.

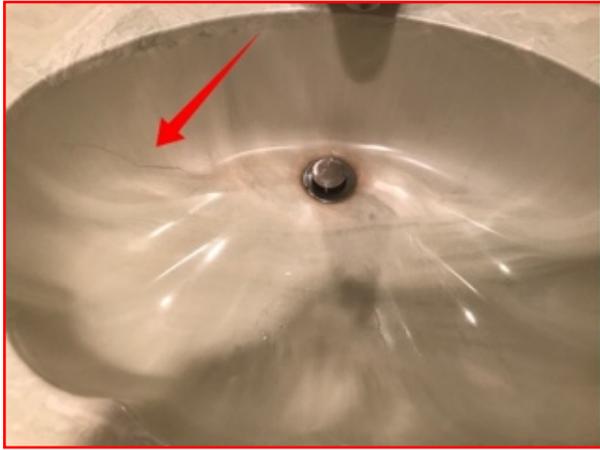
Figure 40-1

34) Comment 40: The sink is cracked and needs to be replaced.

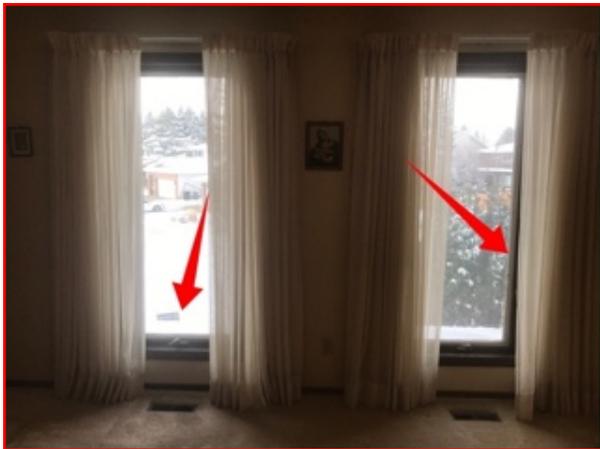
Figure 49-1

43) Comment 49: The handle on the left window is broken and won't allow it to be operated, the right window doesn't open and close smoothly.

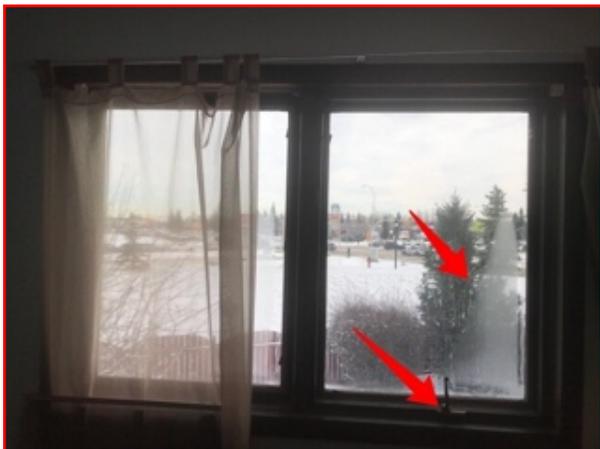
Figure 53-1

47) Comment 53: There is visible moisture on the window and a visible and audible air gap. The window mechanism is also broken and needs to be replaced. Do not open window.

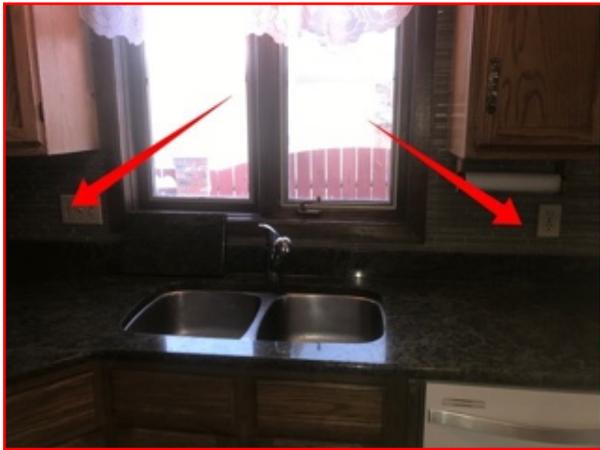
Figure 60-1

53) Comment 60: The counter plugs in the kitchen are within 6' of an open water source and must be gfci protected to prevent electrical shock; recommend replacement.

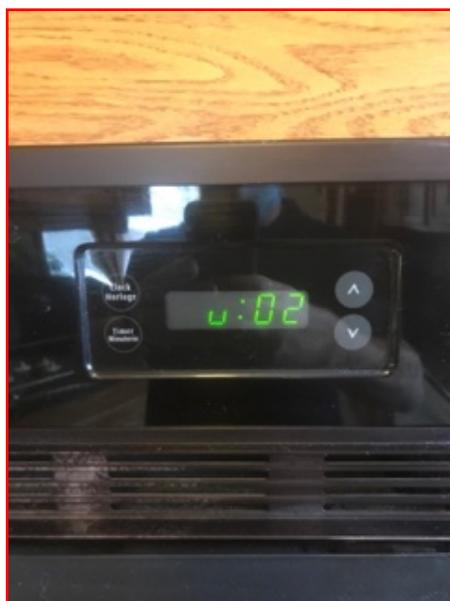
Figure 63-1

56) Comment 63: The digital display is broken .

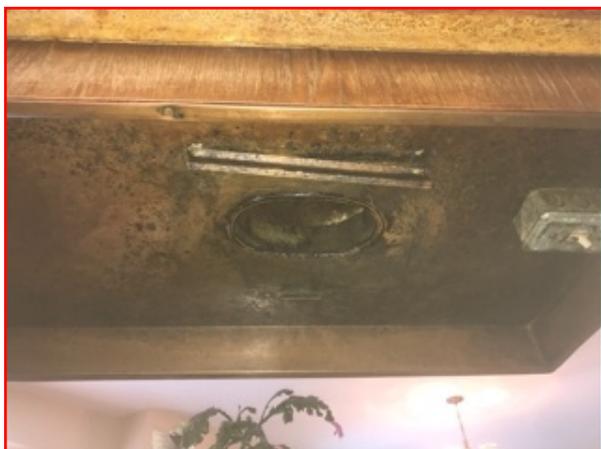
Figure 65-1

57) Comment 65: The good fan is missing the vent cover, the fan has a slight noise to it suggesting that it is wearing out and it is extremely oily and needs to be cleaned to prevent a grease fire.

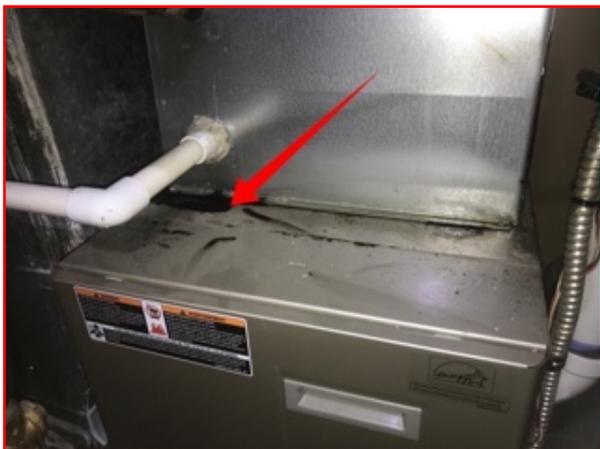
Figure 80-1

66) Comment 80: Unknown black oil tar leaking from inside the furnace ducting; recommend having a licensed HVAC contract assess the unit to figure out where it is coming from. It is believed that the AC coil is leaking oil.

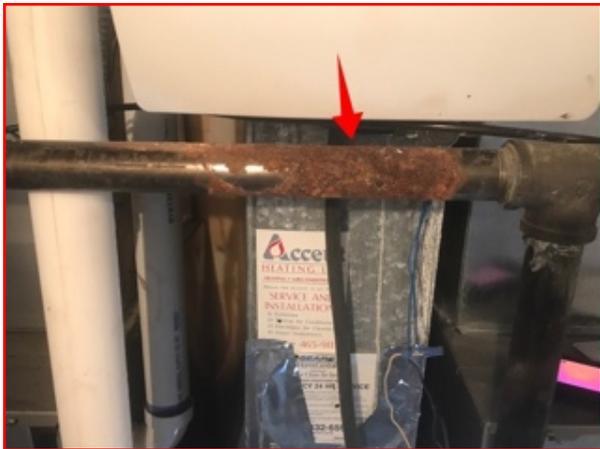
Figure 85-1

70) Comment 85: Natural gas pipe is corroded and needs to be replaced; this is a safety concern as a hole can develop and cause a gas leak.

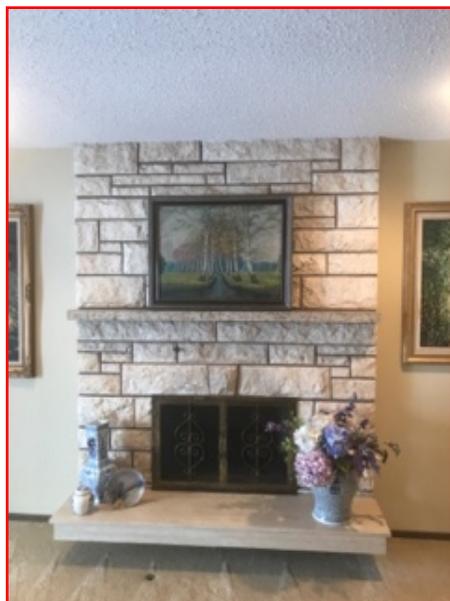
Figure 94-1

74) Comment 94: The fireplace looks lightly used. The gas assist has been disconnected and the flue on the inside isn't working properly and won't close properly high is sucking all of the interior heat up and out the chimney (this can be seen in the FLIR image which was obtained showing the cold cavity). Recommend a WETT certified inspection and repair.

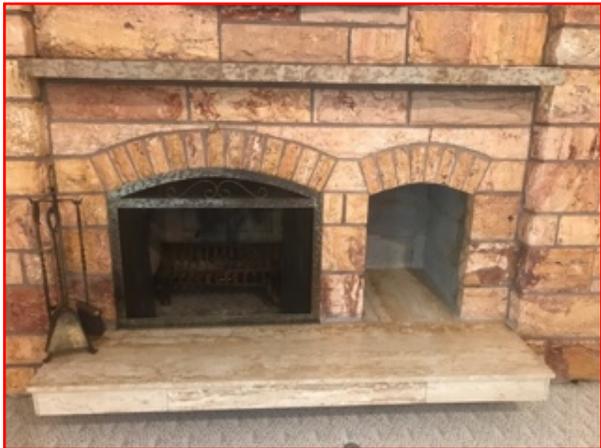
Figure 95-1

75) Comment 95: The flue does not open as it is rusted shut; do not use this fireplace. Recommend a WETT certified inspection and cleaning as the fireplace has soot build up.

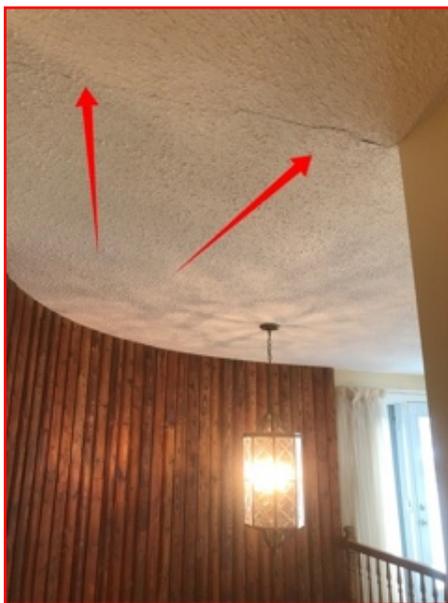
Figure 96-1

76) Comment 96: There is a visible crack and separating in the ceiling to the hallway on the second floor; recommend repair.
