# Brown's Home Inspections Ltd. (License # 352839)

## Home Inspection Report

**Edmonton, AB**

Inspected on Wed, Nov 17 2021 at 1:30 PM

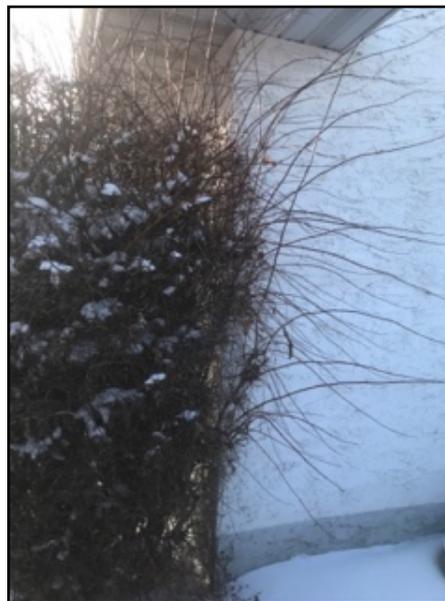
Figure 1-2

Growing Against Structure  
Condition: Repair or Replace

Vegetation is growing against the structure which can cause premature wear and tear against the structural building and roof. Recommend the bushes be trimmed back from the structure.

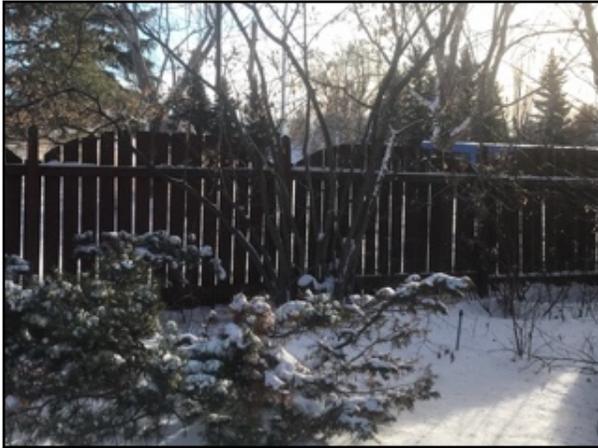
Figure 2-1

Wood, Brick  
Condition: Repair or Replace

The fence is near its end of its life. There are brick columns near falling over if pushed on and there are sections of wood that are in need of repair.

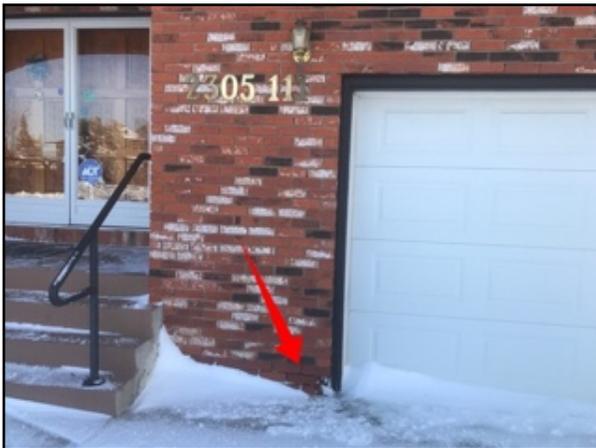
Figure 3-1

Exterior Covering: Brick, Stucco  
Condition: Repair or Replace

The brick on the house is a veneer however it is very heavy. The bottom left and bottom right and above the garage door has started to crumble and is missing bricks in spot. This needs to be repairs immediately to prevent moisture intrusion, further spalling and separation of the brick veneer.

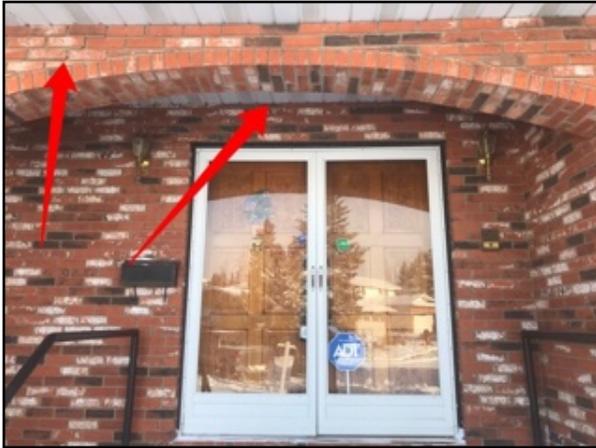
Figure 4-1

The keystone brick is loose in the Center; this holds the entire arch together. Without this properly sound the brick can fall out injuring someone and cause a collapse of the arc; recommend immediate repair.

Upper left applies as well.

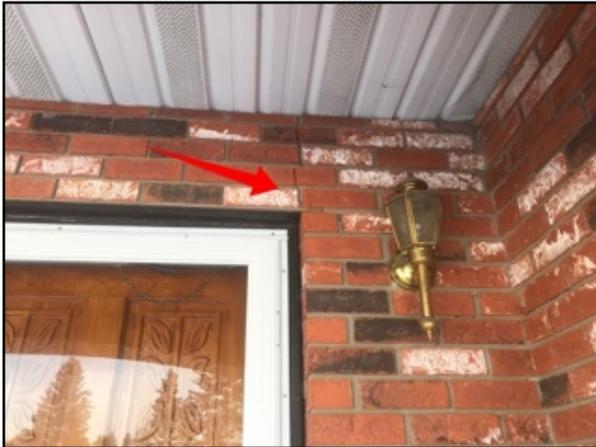
Figure 5-1

The brick to the upper right of the door has cracked through the brick and not around the brick in the mortar joint; this indicates a structural shift in the brick veneer; recommend repair from a brick mason.

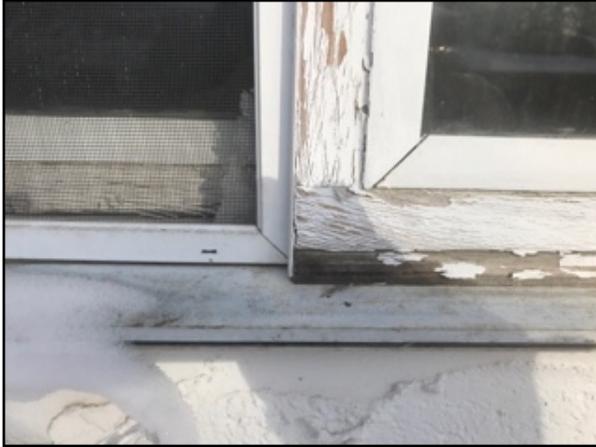
Figure 7-1

I have taken one photo to represent the condition of the exterior of the wood windows. Though not rotten, all windows need to be scraped and painted to prevent further damage and moisture intrusion.

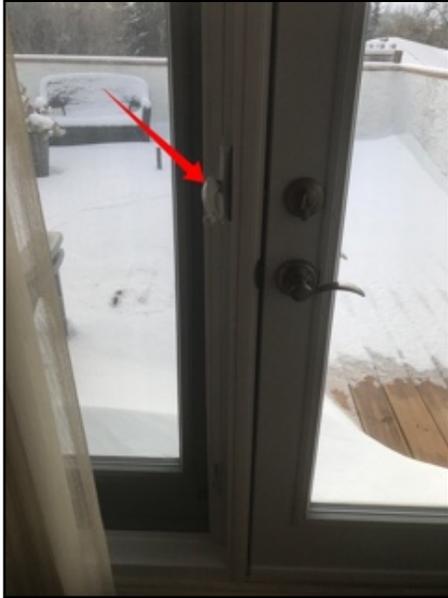
Figure 8-1

The handle to the vent window is loose and coming off.

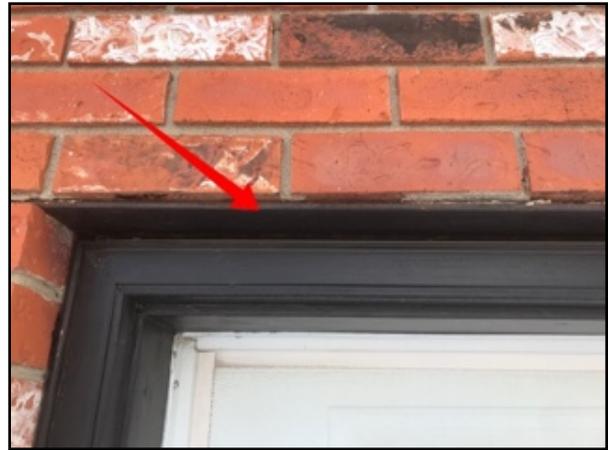
Figure 9-2

The metal lintel above the front door and garage door is starting to rust; recommend painting to prevent just from occurring and compromising the steel lintels.

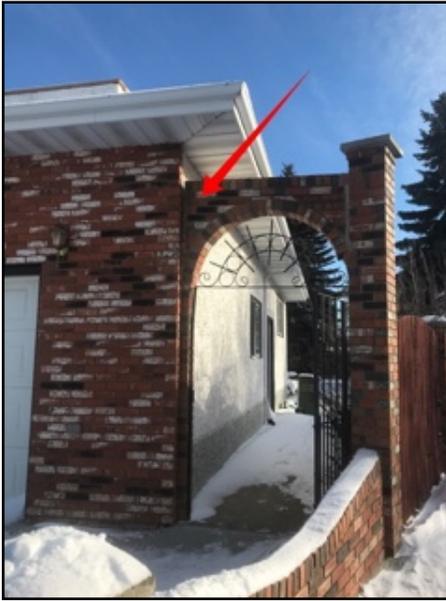
Figure 10-1

The right pillar has shifted and sunk which has caused the brick to pull away from the house; this is a safety concern and could fall on someone; recommend immediate repair.

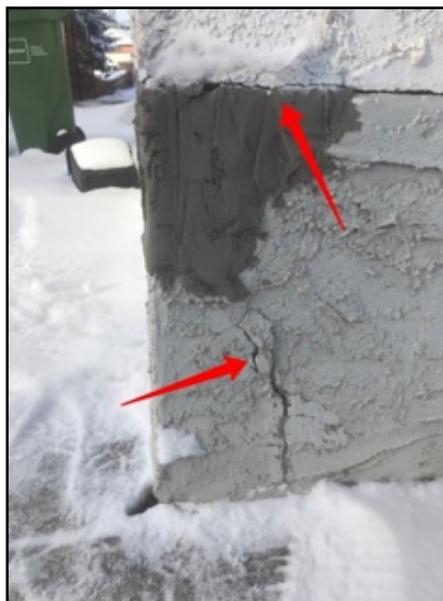
Figure 11-2

The se corner of the garage has had repair to it. There is a hole right below where the footing should be which suggests there can be structural movement below. Some repair has been attempted but it has not held together; recommend further proper repair.

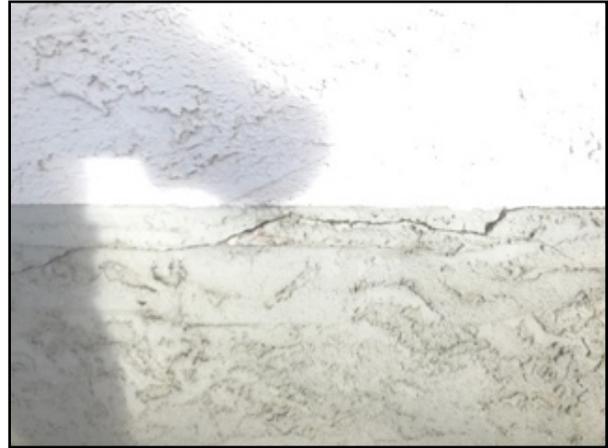
Figure 13-2

**Comment 13:**  
I have provided a sample of the cracks in the parging around the house;  
recommend repair of the parging to prevent moisture intrusion.

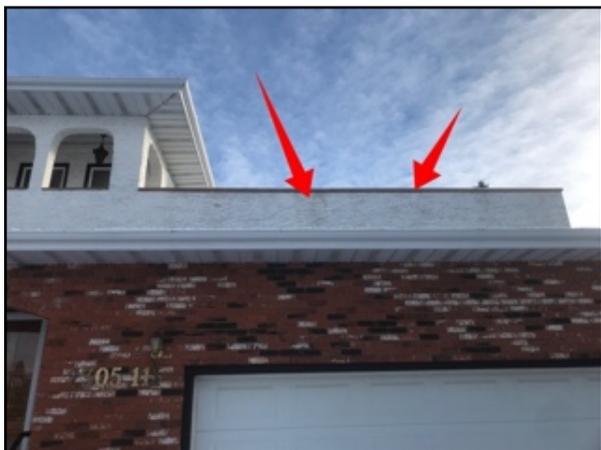
Figure 14-1

The stucco has been painted over at some point in time and there are areas around the house where the paint is starting to flake off. I have provided a sample image of what I am describing.

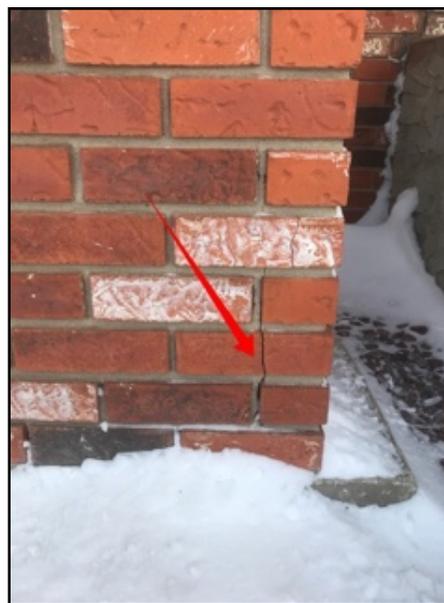
Figure 15-2

Minor separating the brick and mortar cracking on the pillar to the left of the front door; recommend repair to prevent further damage.

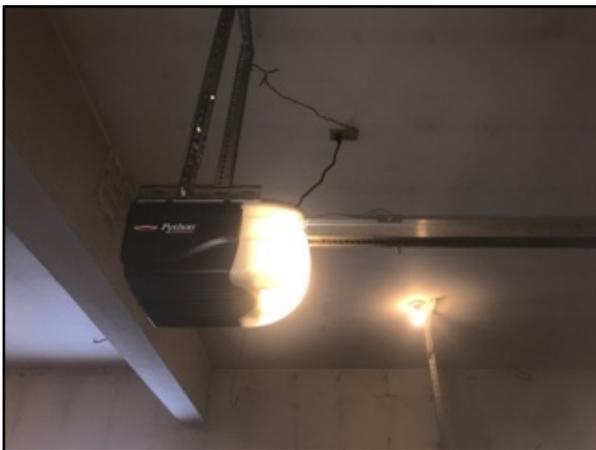
Figure 16-1

The pressure safety feature on the garage door opener does not work; recommend correcting as it is a safety issue.

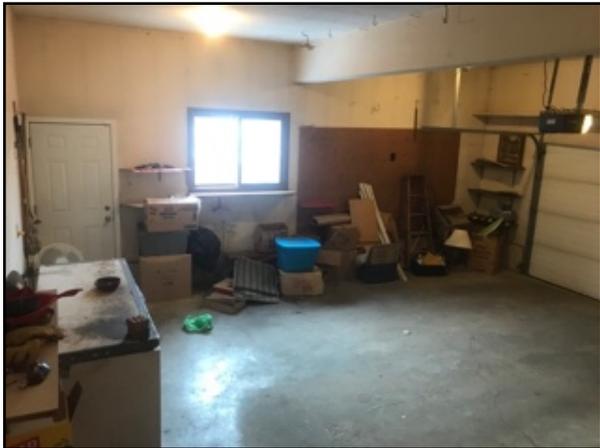
Figure 17-1

Comment 17:  
The garage smells heavily of cigarette smoke.

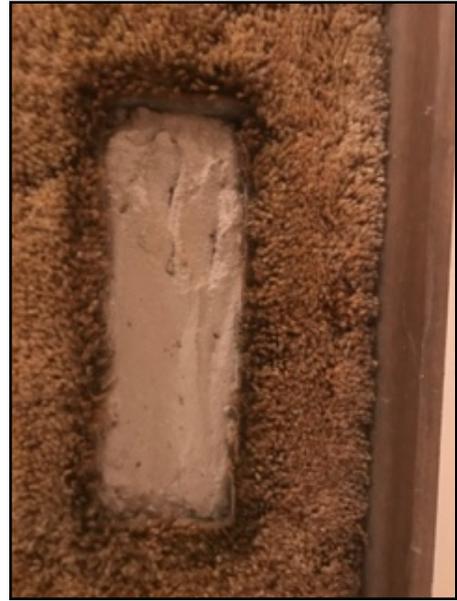
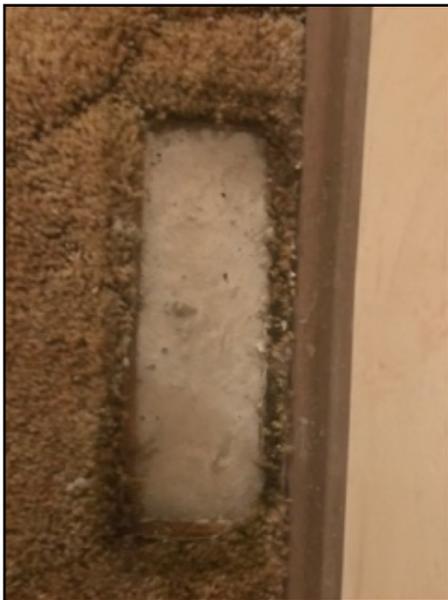
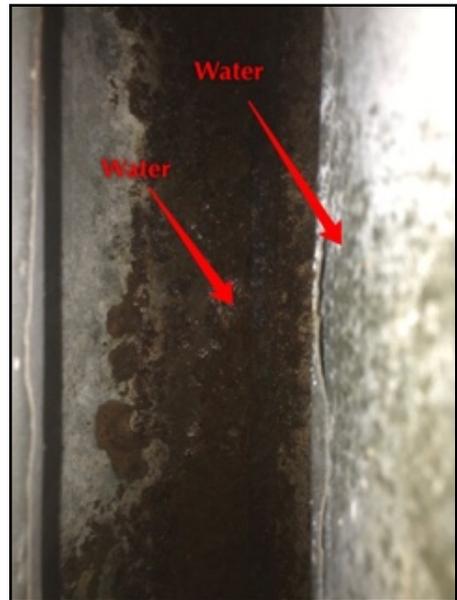
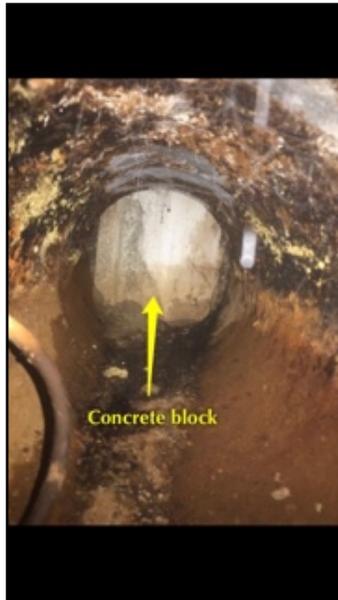
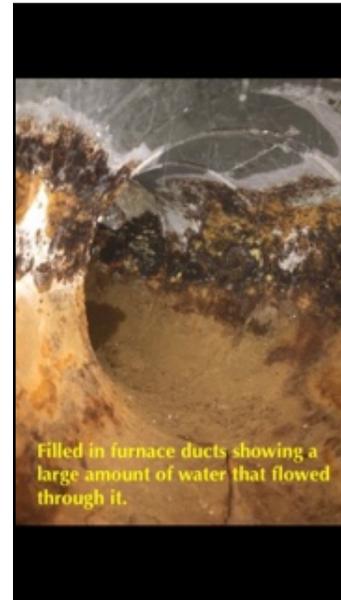
The in floor furnace ducting has been filled in with concrete except for one register. Upon inspection of the register there is rust in the bottom of it and active water (wet on my hand) present within the ducting. I believe there is a moisture problem under the slab as there is no weeping system. I believe that the water has infiltrated the ducting which is why they filled it in instead of installing a proper weeping system.

I have obtained images from within the old furnace cavity which shows the filled in concrete block and the fact that the flooring vents were 3/4 full of water at some point in time which has caused all of the rust seen in the images.

Recommend asking the home owner for more information.

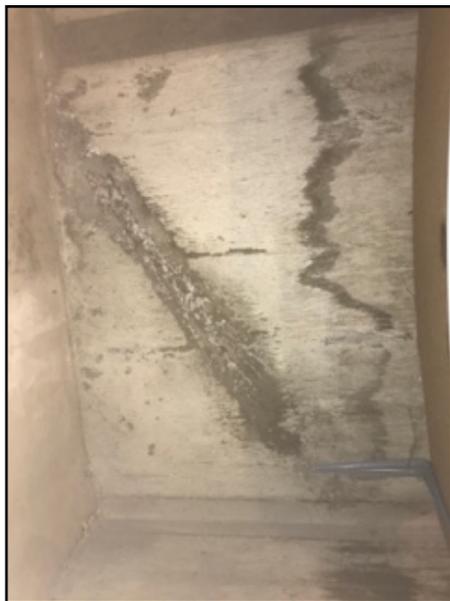
Figure 19-1

Comment 19:  
Signs of previous patch working being done. It is dry at this time.

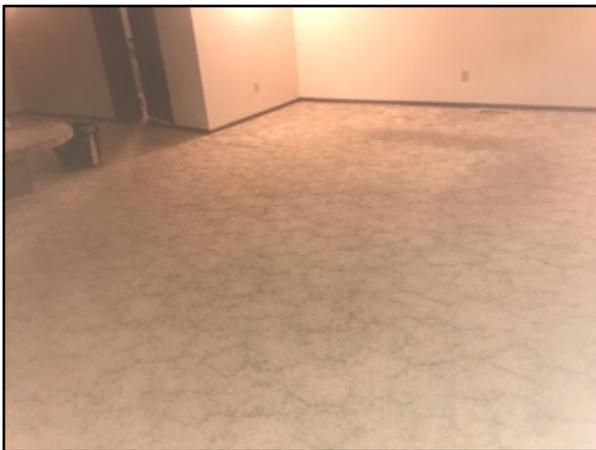
Figure 21-1

Comment 21:  
Staining throughout.

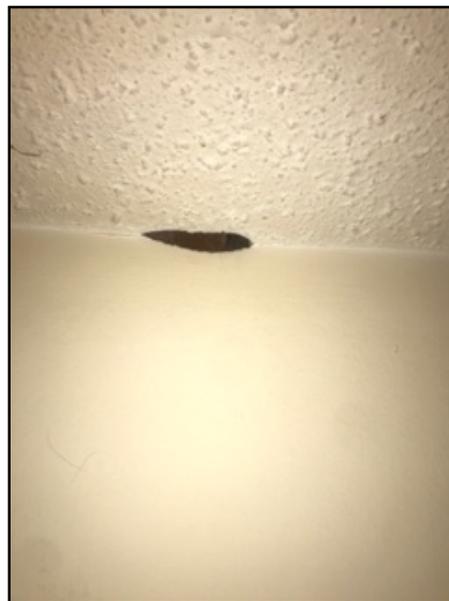
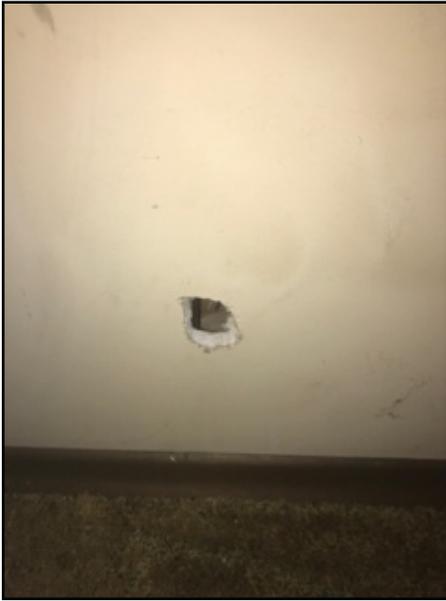
Comment 23:  
There are various areas throughout the basement where there are holes in the walls.

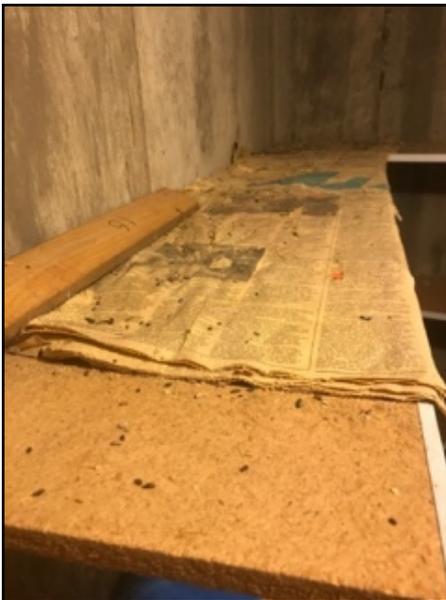
Figure 24-1

Comment 24:  
Signs of rodents.

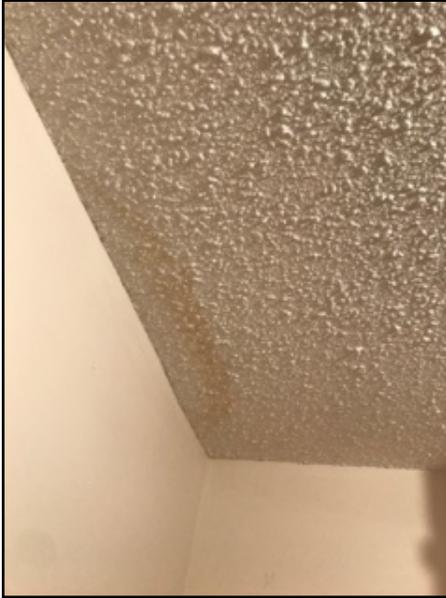
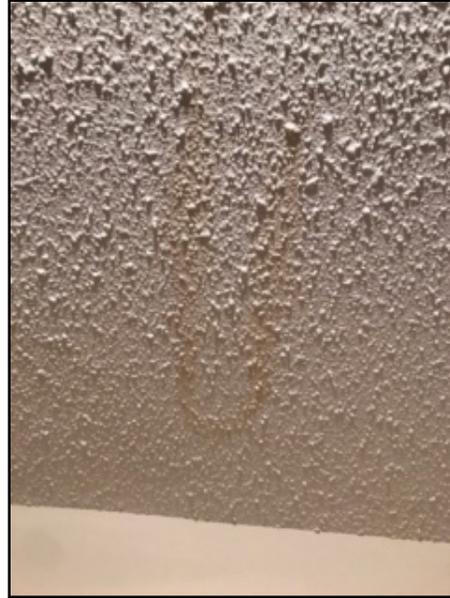
Unknown water staining in the ceiling of the electrical room. FLIR thermal camera didn't reveal any concerns.

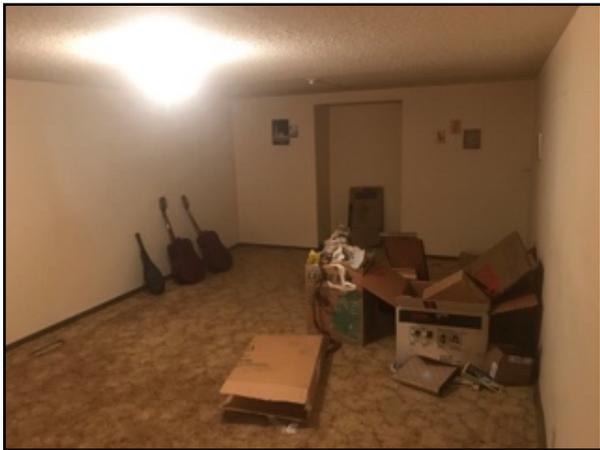
Figure 26-1

There is no heat in this room.

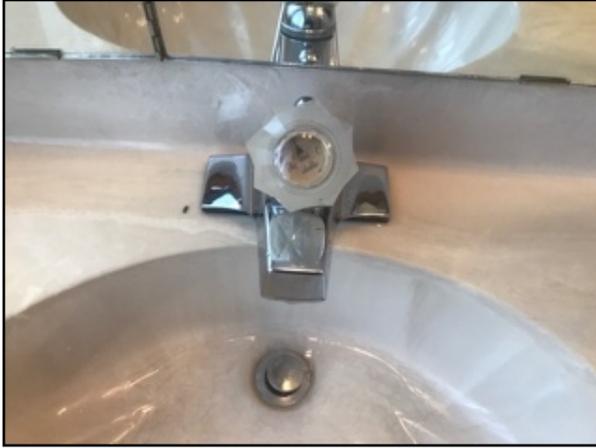
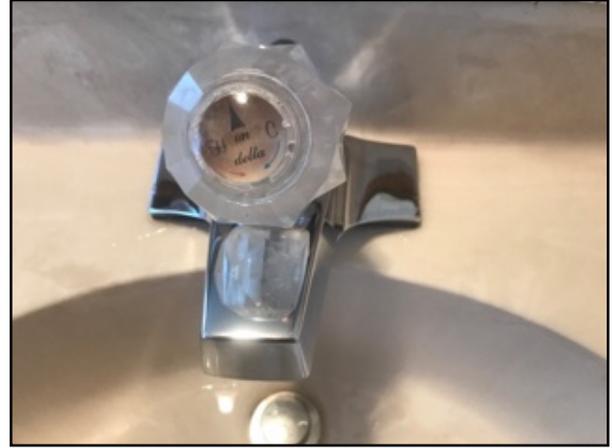
Comment 28:  
Both taps leak; recommend replacement.

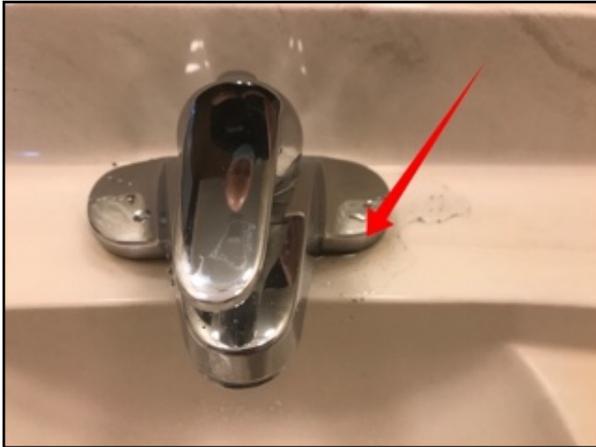
Figure 32-1

Comment 32:  
The tap is leaking; recommend replacement.

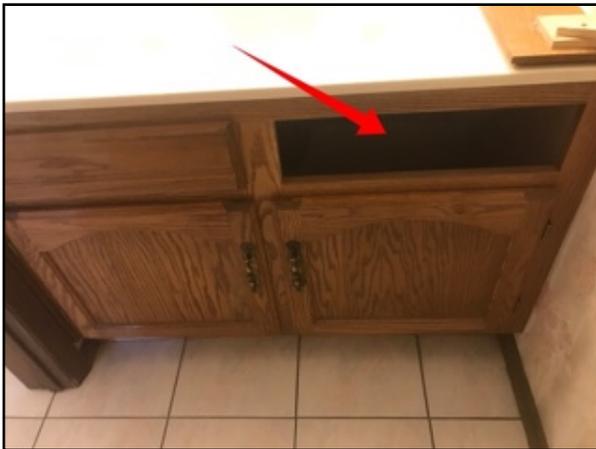
Figure 33-1

Comment 33:  
Broken vanity.

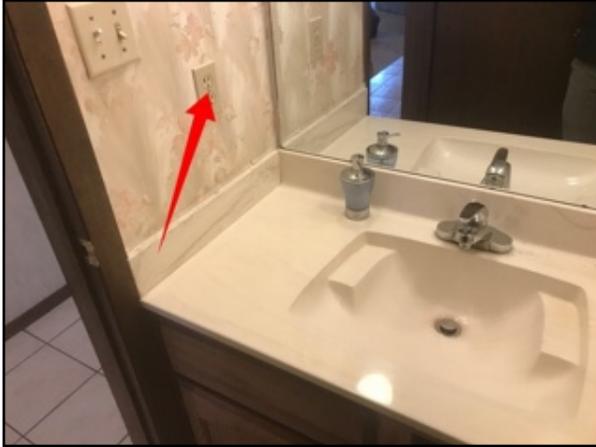
Figure 35-1

The counter plug is within 6' of an open water source and must be gfci protected to prevent electrical shock; recommend replacement.

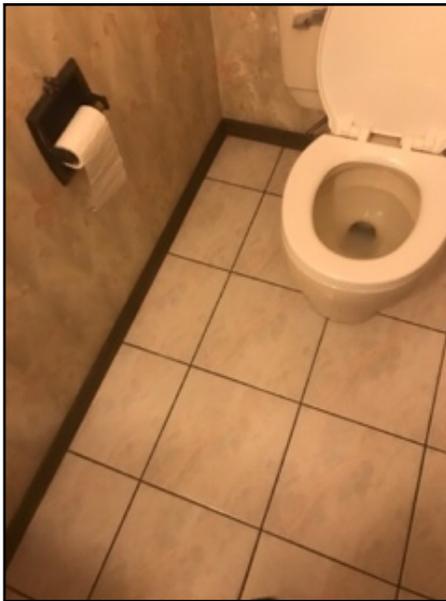
Figure 36-1

There is no heat source in the half bathroom and there should be; recommend repair.

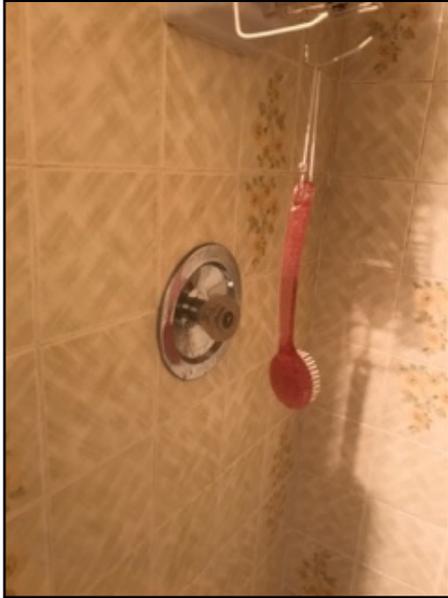
Figure 38-1

**Comment 38:**  
The hot and cold was hooked up in reverse.

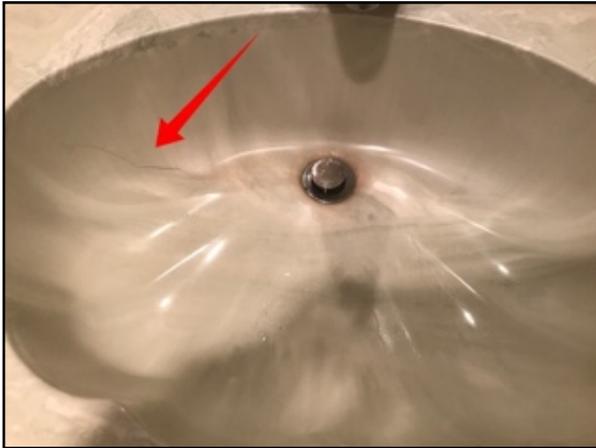
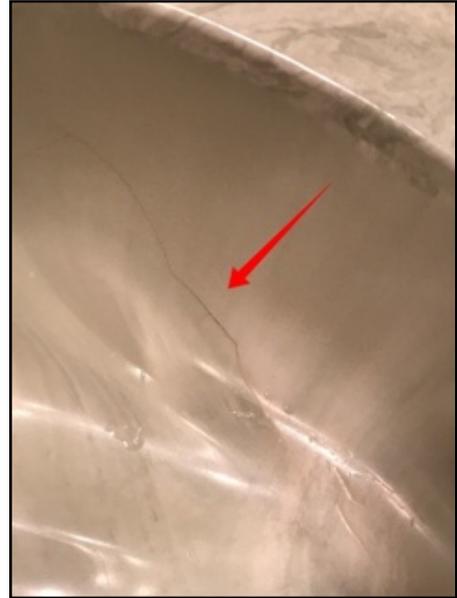
The sink is cracked and needs to be replaced.

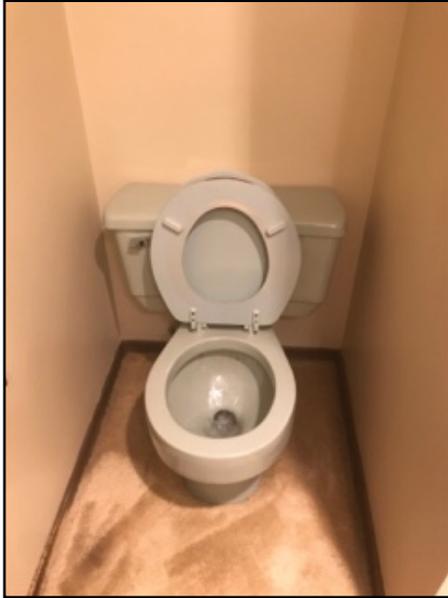
Figure 41-1

Comment 41:  
The toilet is loose and needs to be tightened.

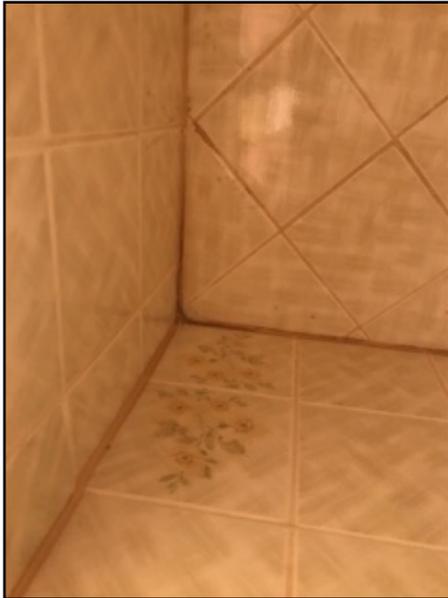
Figure 42-1

Comment 42:  
The caulking needs to be redone in the shower to prevent moisture damage.  
There is also visible mold growing on the caulking.

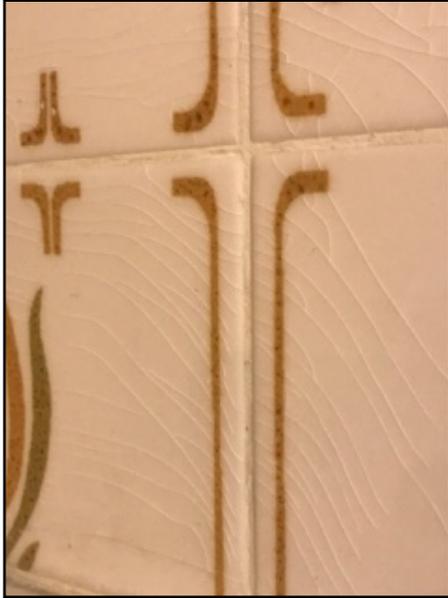
Figure 43-1

There are various tiles that are cracked and the shower base needs to be recaulked.

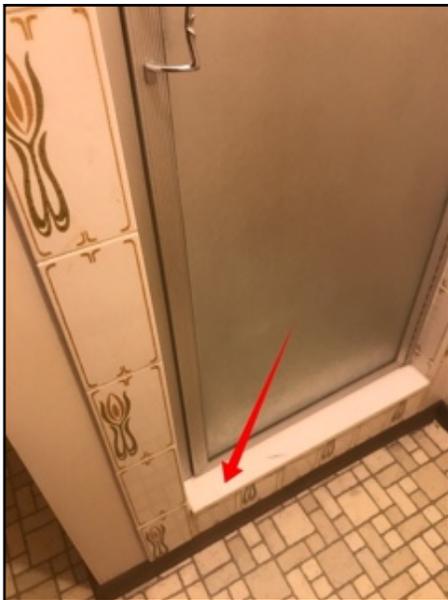
Figure 44-1

The shower door rubs on the sill plate.

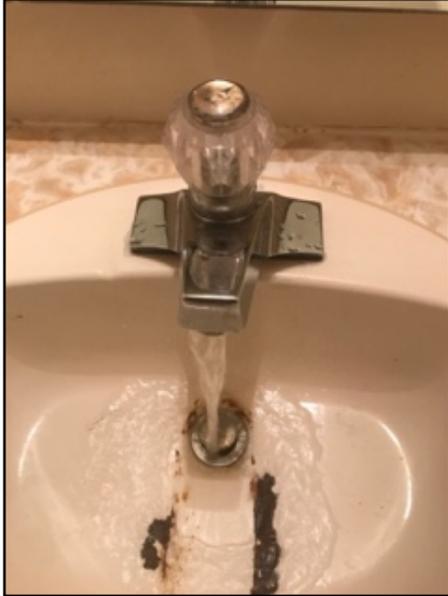
Figure 45-1

The tap leaks and the sinks porcelain is damaged.

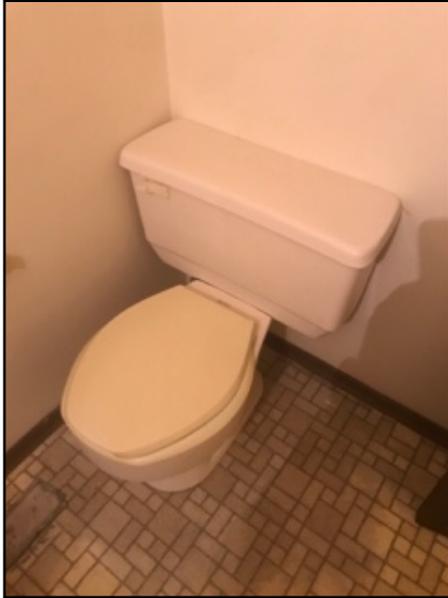
Figure 46-1

The toilet is loose and not connected to the floor.

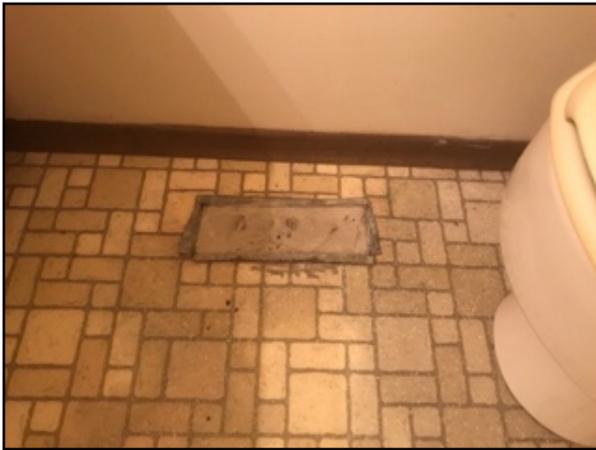
Figure 47-1

There is no heat source on the bathroom as the ducting has been filled in with cement.

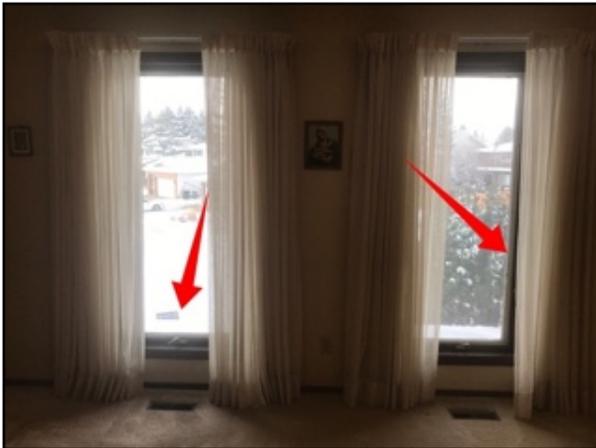
Figure 49-1

The handle on the left window is broken and won't allow it to be operated, the right window doesn't open and close smoothly.

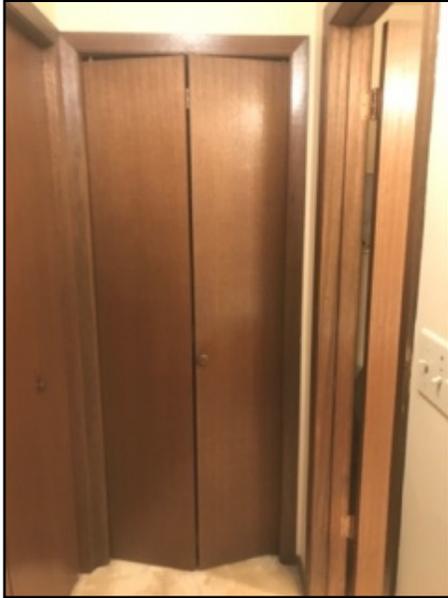
Figure 51-1

Comment 51:  
The bi-fold door in the closet doesn't close.

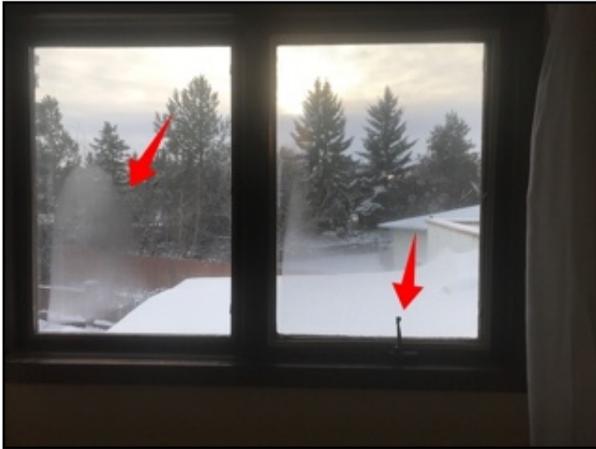
Figure 54-1

There is visible moisture on the window and a visible and audible air gap. The window mechanism is also broken and needs to be replaced. Do not open window.

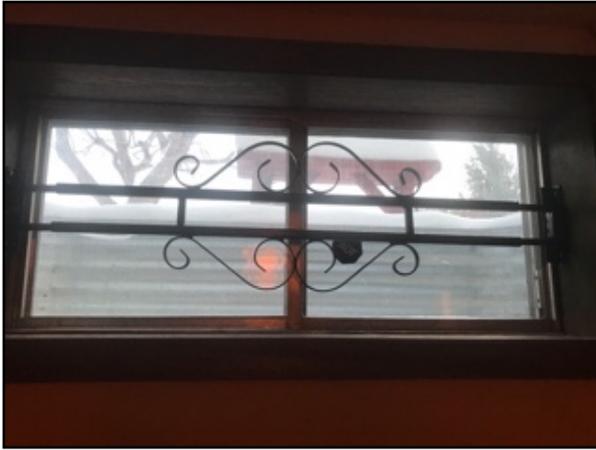
Figure 55-1

Comment 55:  
Won't open.

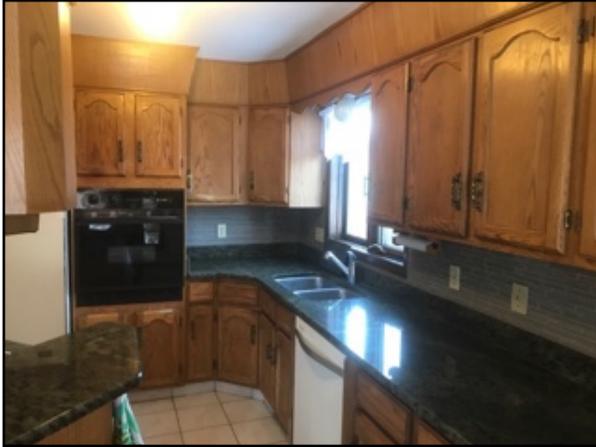
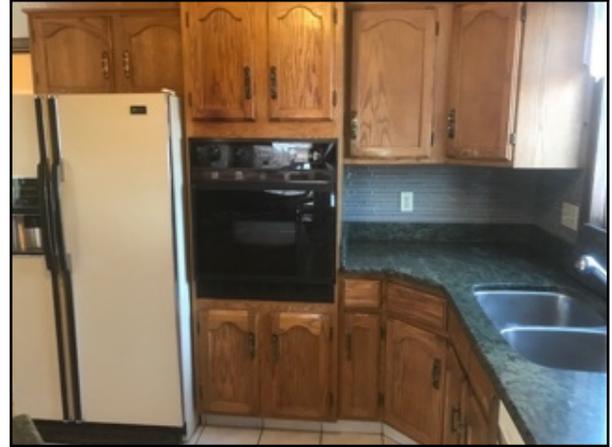
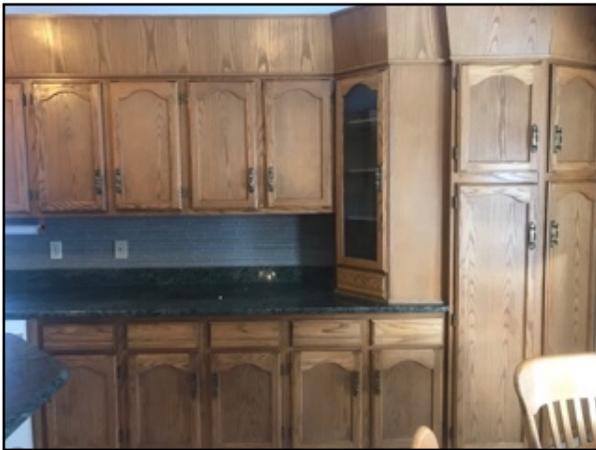
Comment 56:  
The cabinets are original to the home and show their wear and tear. The finish is coming off on some doors and drawers and the drawer slides are wearing out; recommend repair and replacement of items needed.

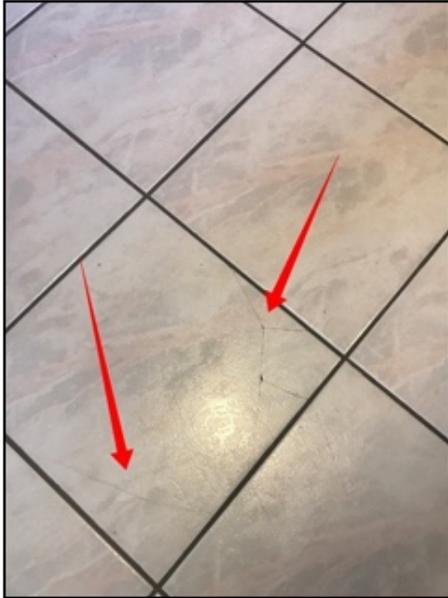
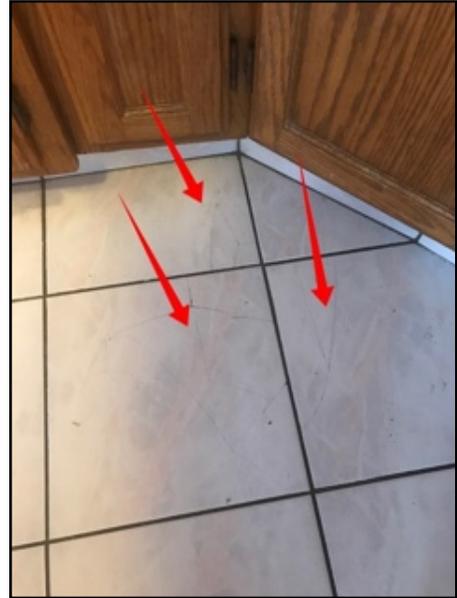
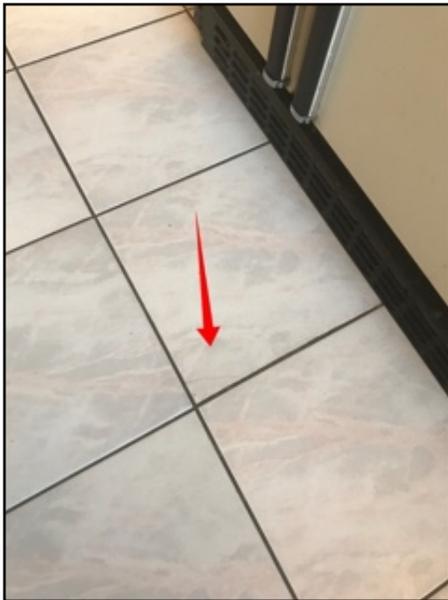
There are cracked tiles throughout the kitchen; recommend replacement.

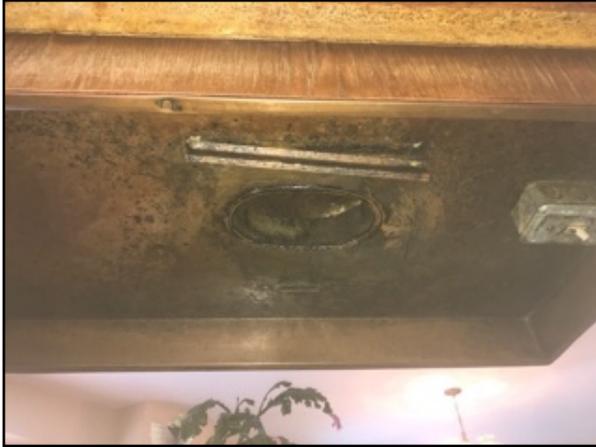
Figure 65-1

Comment 65:  
The good fan is missing the vent cover, the fan has a slight noise to it suggesting that it is wearing out and it is extremely oily and needs to be cleaned to prevent a grease fire.

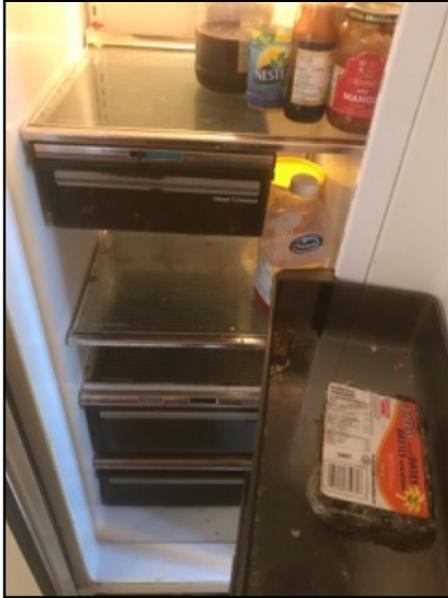
Figure 67-1

Comment 67:  
The fridge is very dirt and smells badly.

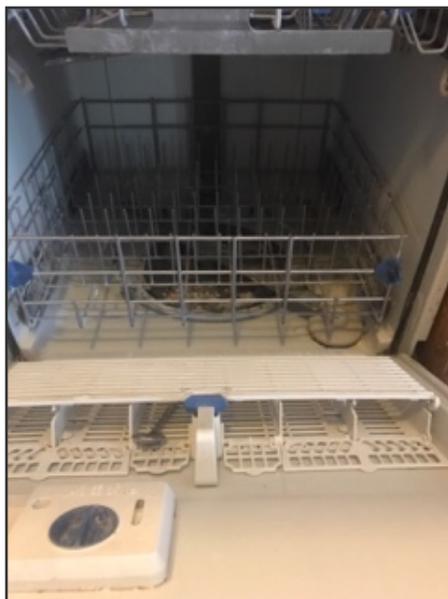
Figure 68-1

The dishwasher works at the time of inspection but it is very dirty, smells and needs to be cleaned.

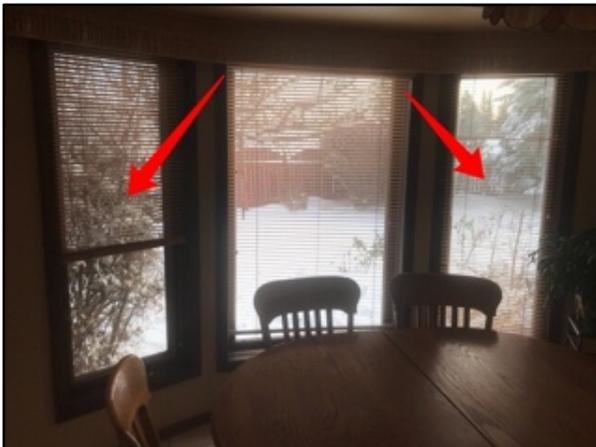
Figure 69-1

The left window doesn't open due to overgrowth and the right window is very hard to open and close; recommend replacement.

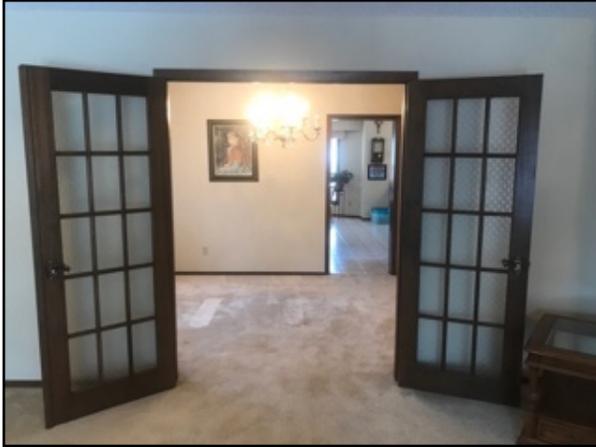
Figure 70-1

This set of doors doesn't close properly due to warped doors and thick carpet; recommend repair.

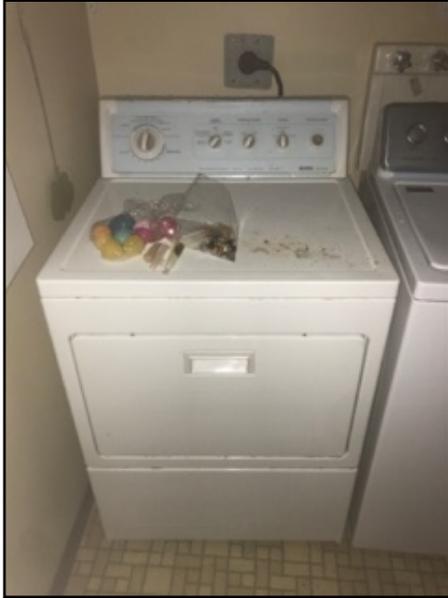
Figure 71-1

Comment 71:

There is a hum to the motor which suggests that it isn't balance; recommend repair.

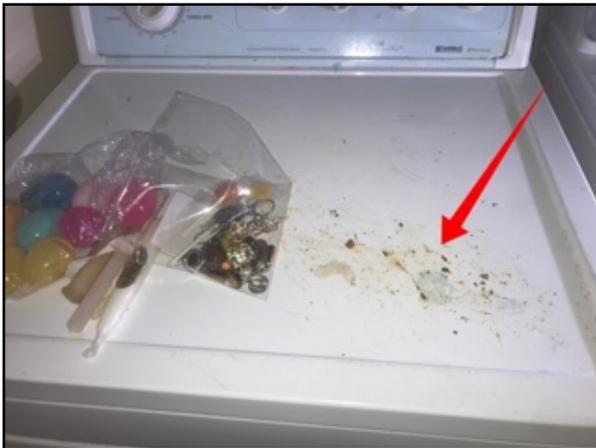
Figure 72-1

Comment 72:

Rust and damaged top.

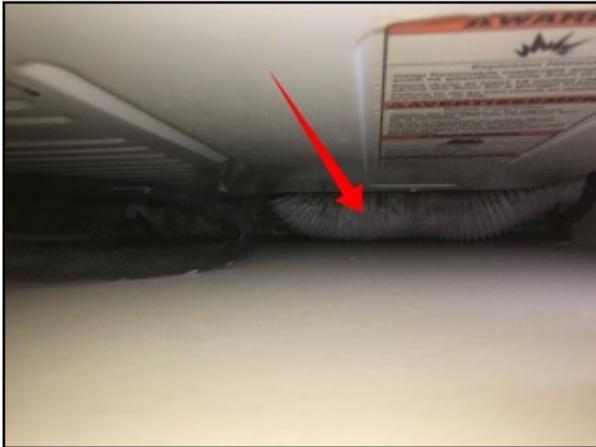
Figure 73-1

Comment 73:

The dryer vent is an expandable flex hose which causes build up of lint in the ripples of the hose; this is a safety concern. Recommend a general contractor or HVAC mechanic replace the expandable flex hose with a straight pipe.

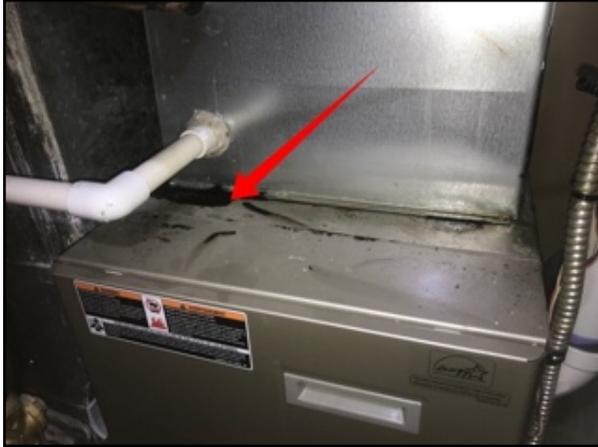
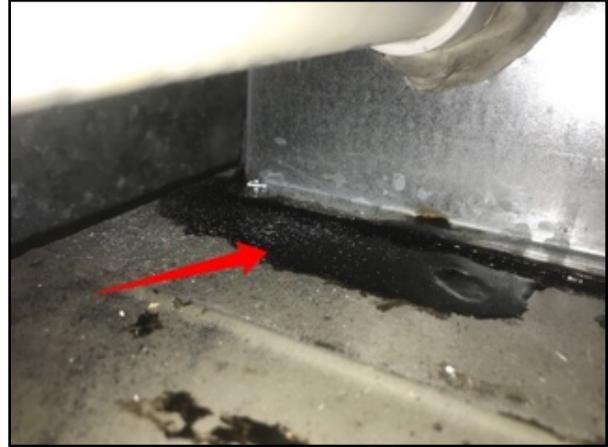
Unknown black oil tar leaking from inside the furnace ducting; recommend having a licensed HVAC contract assess the unit to figure out where it is coming from. It is believed that the AC coil is leaking oil.

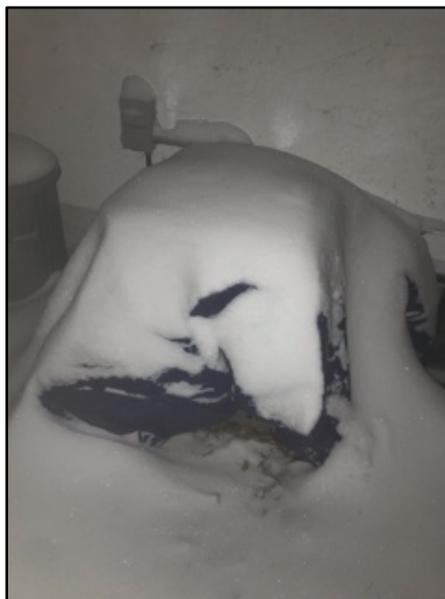
Unknown, not visible as it is tarped for the winter.

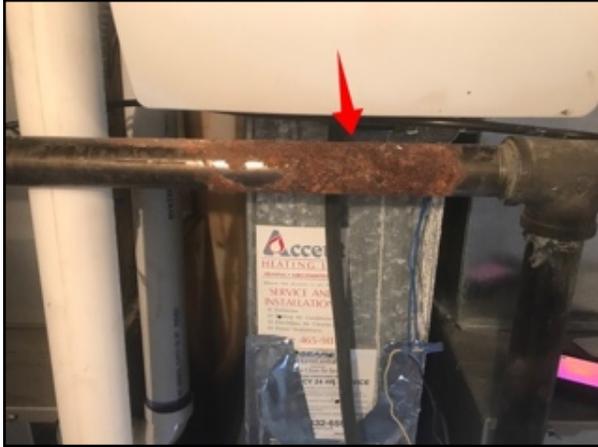
Figure 85-1

Natural gas pipe is corroded and needs to be replaced; this is a safety concern as a hole can develop and cause a gas leak.

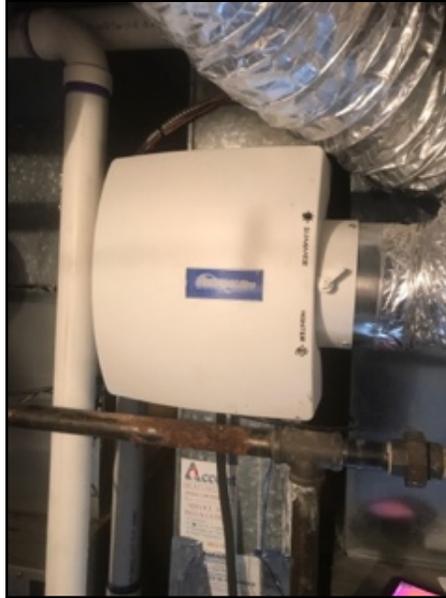
Condition: Repair or Replace

Comment 87:

There is an active water leak; recommend repair.

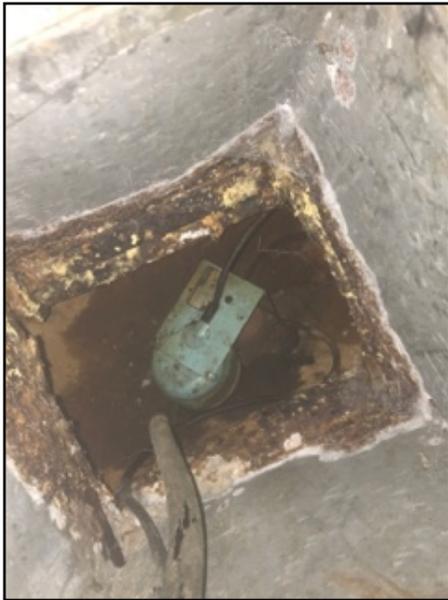
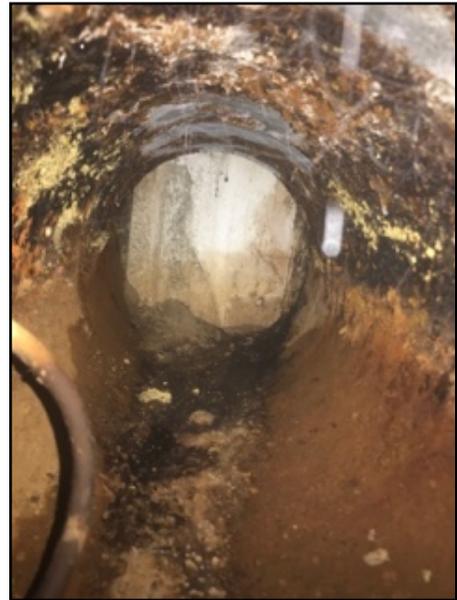
Comment 90:

There is a sump pump placed inside of the old furnace venting to pump out the excess water.

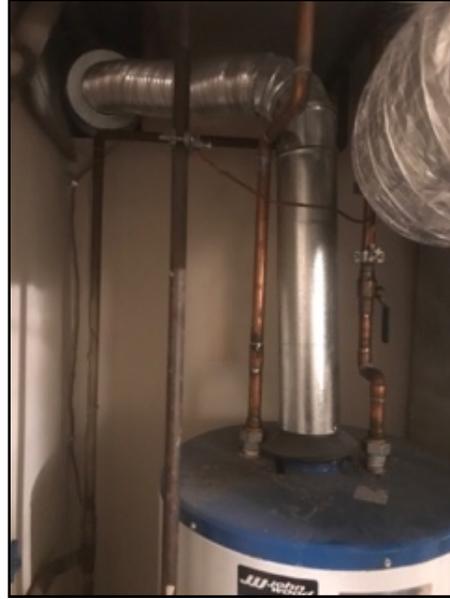
Figure 93-2

Temp & Pressure Relief Valve:	Present With Blow Off Leg Condition: Satisfactory
Fuel Disconnect:	In Same Room
Supply Lines:	Copper Condition: Satisfactory
Combustion Chamber:	Some corrosion observed; recommend cleaning. Condition: Marginal
Venting:	Metal Condition: Satisfactory

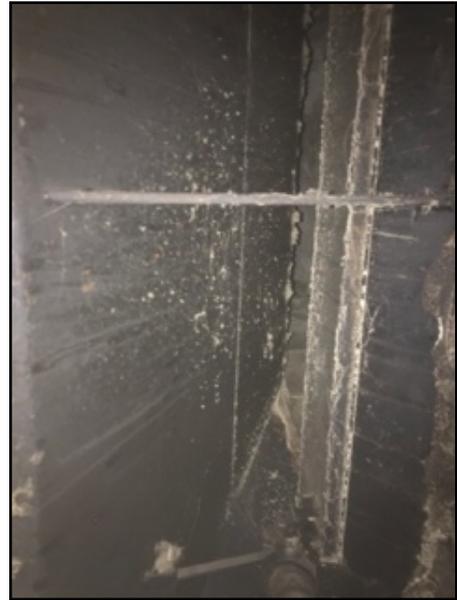
Figure 94-2

The fireplace looks lightly used. The gas assist has been disconnected and the flue on the inside isn't working properly and won't close properly high is sucking all of the interior heat up and out the chimney (this can be seen in the FLIR image which was obtained showing the cold cavity). Recommend a WETT certified inspection and repair.

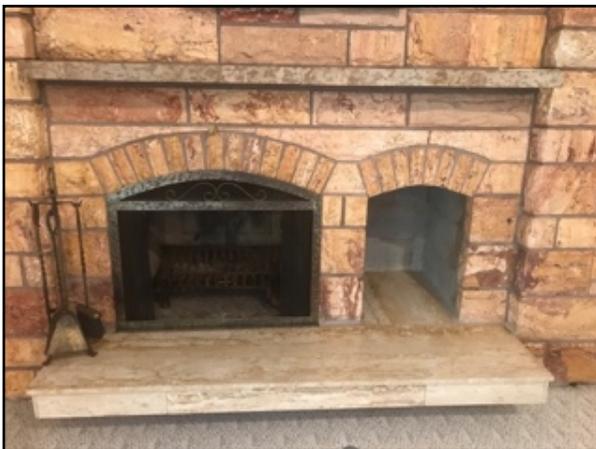
Figure 95-1

The flue does not open as it is rusted shut; do not use this fireplace. Recommend a WETT certified inspection and cleaning as the fireplace has soot build up.

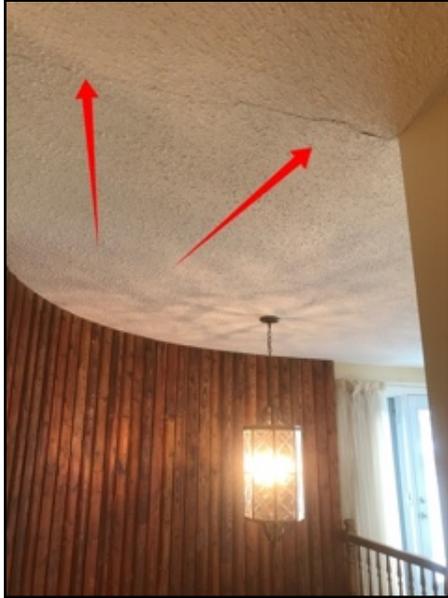
Figure 96-1

There is a visible crack and separating in the ceiling to the hallway on the second floor; recommend repair.

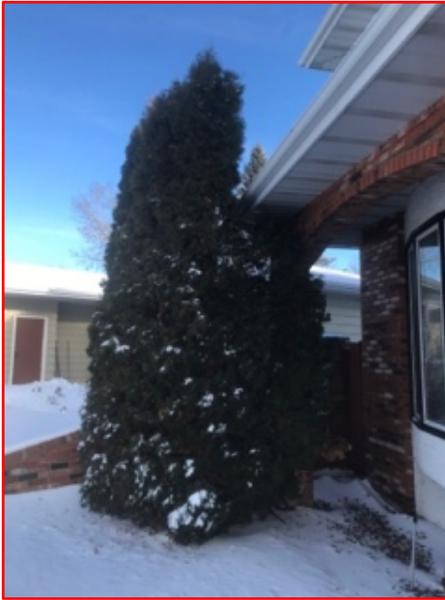
Figure 1-1

1) Comment 1: Vegetation is growing against the structure which can cause premature wear and tear against the structural building and roof. Recommend the bushes be trimmed back from the structure.

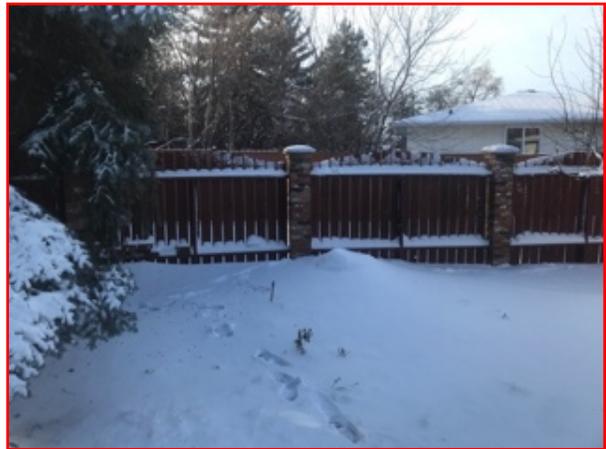
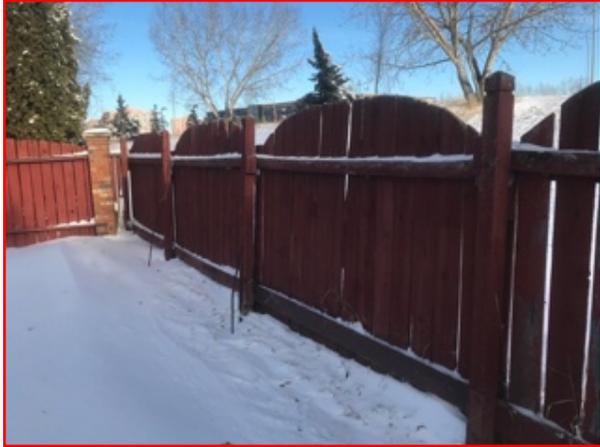
2) Comment 2: The fence is near its end of its life. There are brick columns near falling over if pushed on and there are sections of wood that are in need of repair.
