# Brown's Home Inspections Ltd. (License # 352839)

## Home Inspection Report

**Edmonton, AB**

Inspected on Wed, Nov 17 2021 at 1:30 PM

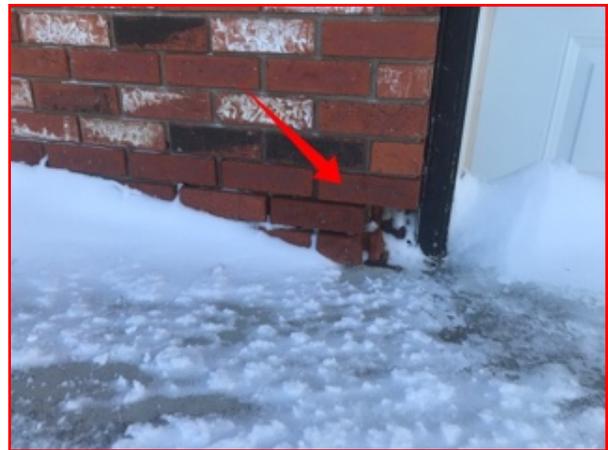
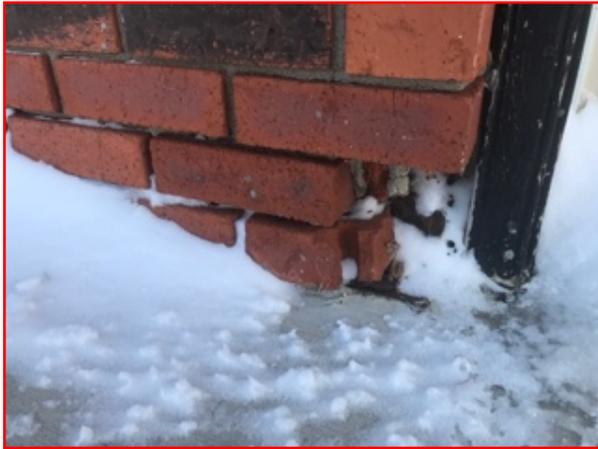
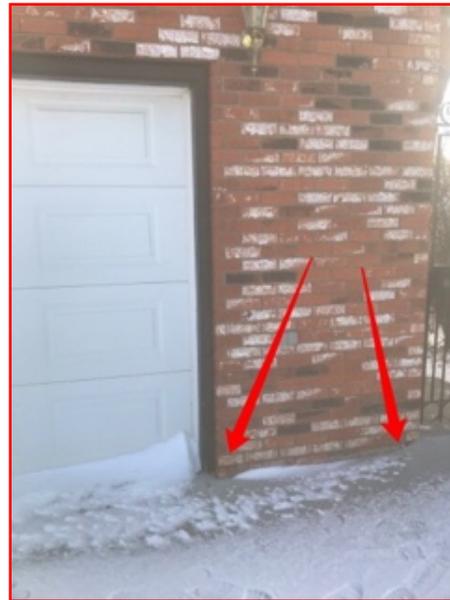
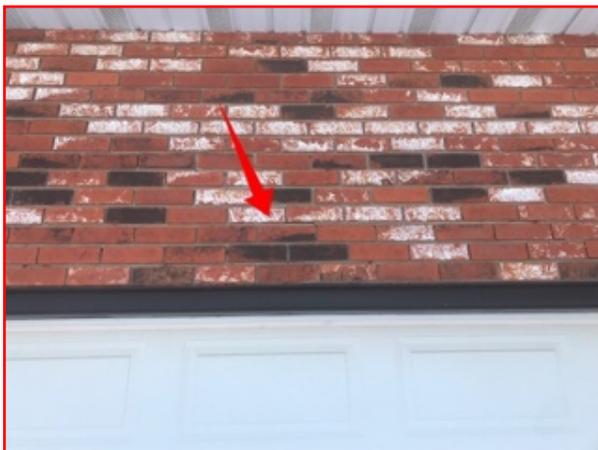
3) Comment 3: The brick on the house is a veneer however it is very heavy. The bottom left and bottom right and above the garage door has started to crumble and is missing bricks in spot. This needs to be repairs immediately to prevent moisture intrusion, further spalling and separation of the brick veneer.

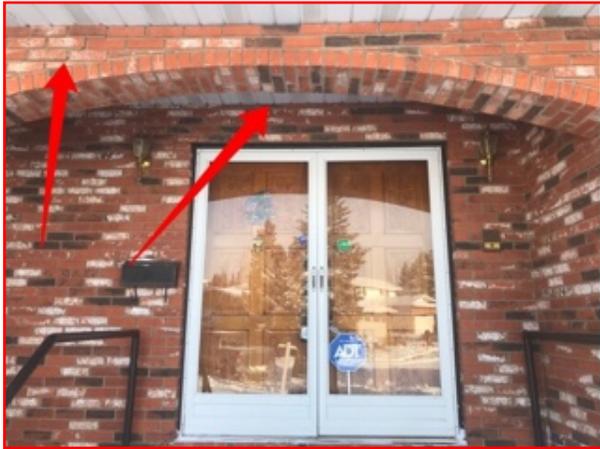
Figure 4-1

4) Comment 4: The keystone brick is loose in the Center; this holds the entire arch together. Without this properly sound the brick can fall out injuring someone and cause a collapse of the arc; recommend immediate repair.

Upper left applies as well.

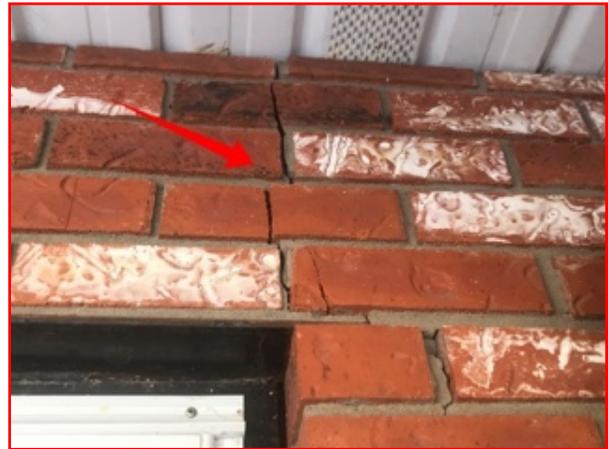
Figure 5-2

5) Comment 5: The brick to the upper right of the door has cracked through the brick and not around the brick in the mortar joint; this indicates a structural shift in the brick veneer; recommend repair from a brick mason.

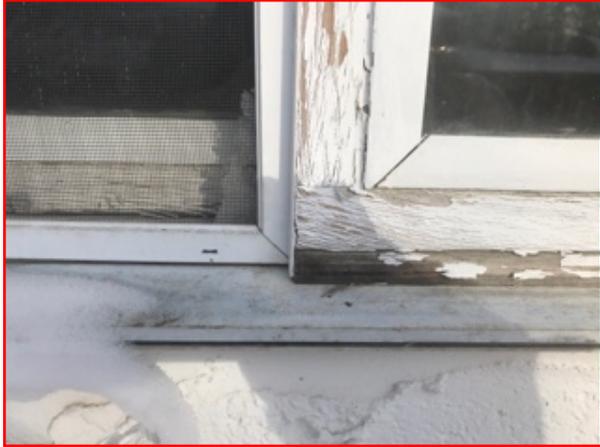
Figure 7-1

6) Comment 7: I have taken one photo to represent the condition of the exterior of the wood windows. Though not rotten, all windows need to be scraped and painted to prevent further damage and moisture intrusion.

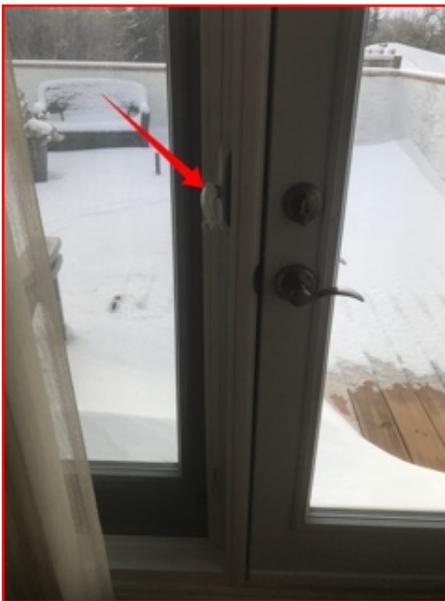
Figure 8-1

7) Comment 8: The handle to the vent window is loose and coming off.

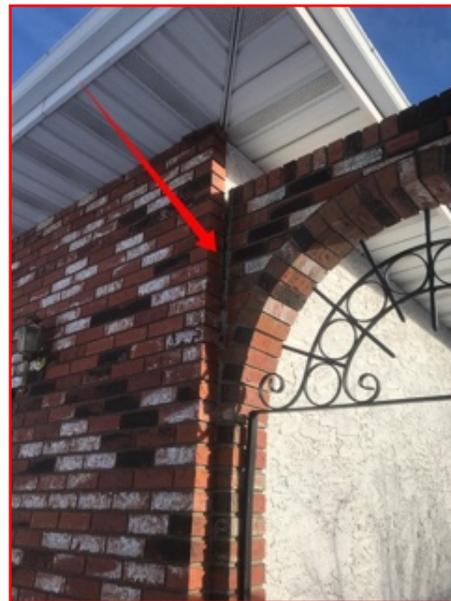
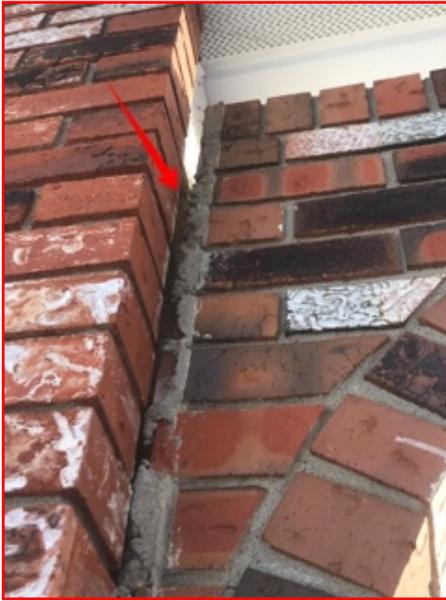
9) Comment 10: The right pillar has shifted and sunk which has caused the brick to pull away from the house; this is a safety concern and could fall on someone; recommend immediate repair.

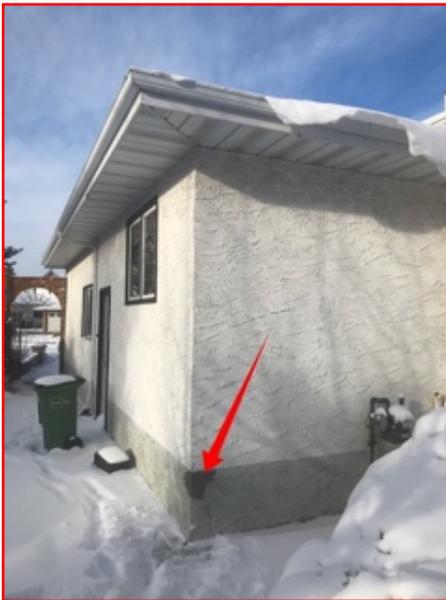
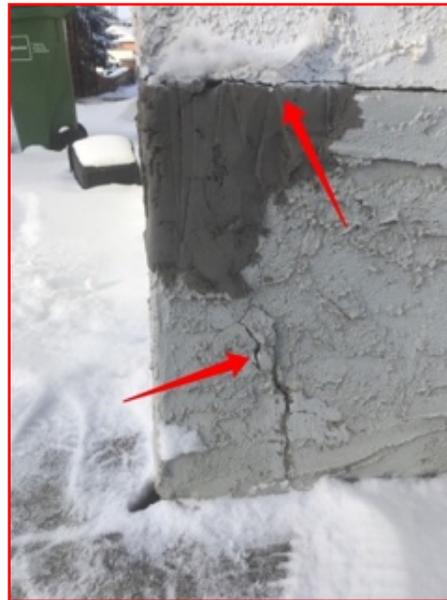
10) Comment 11: The se corner of the garage has had repair to it. There is a hole right below where the footing should be which suggests there can be structural movement below. Some repair has been attempted but it has not held together; recommend further proper repair.

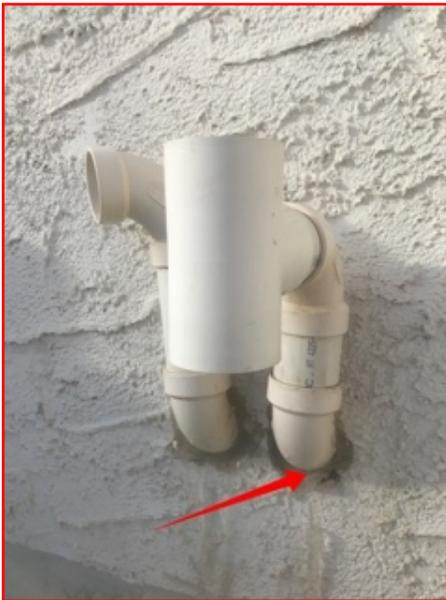
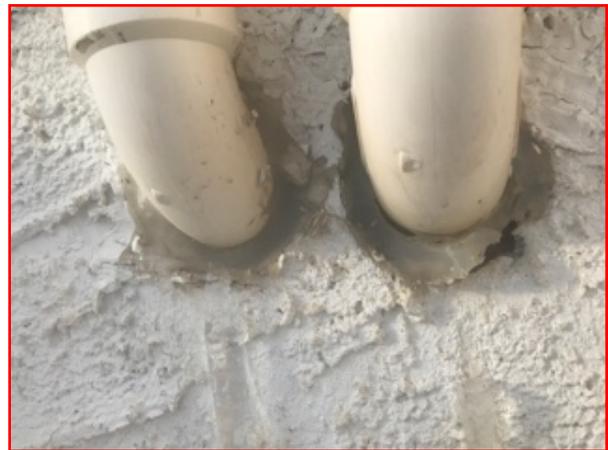
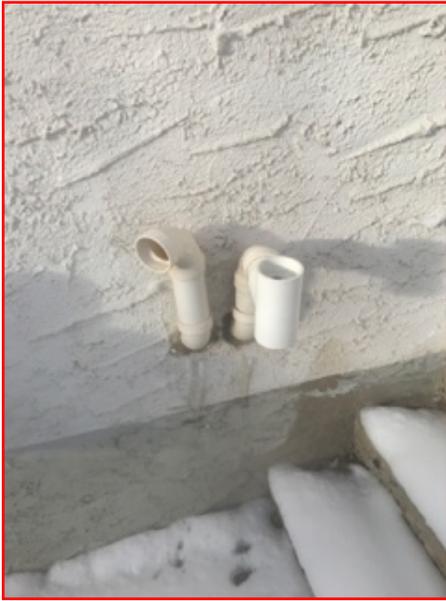
11) Comment 12: Recommend caulking to prevent moisture intrusion.

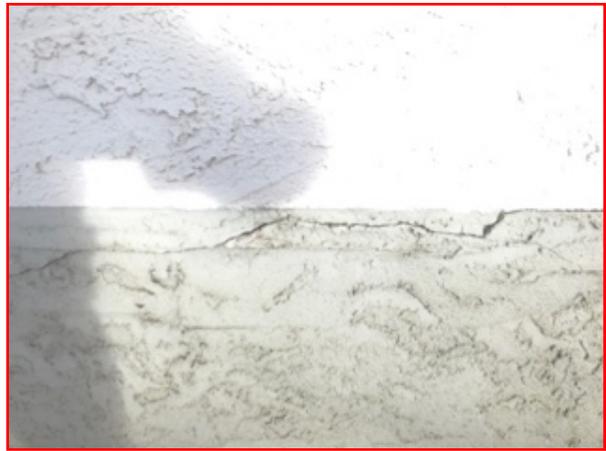
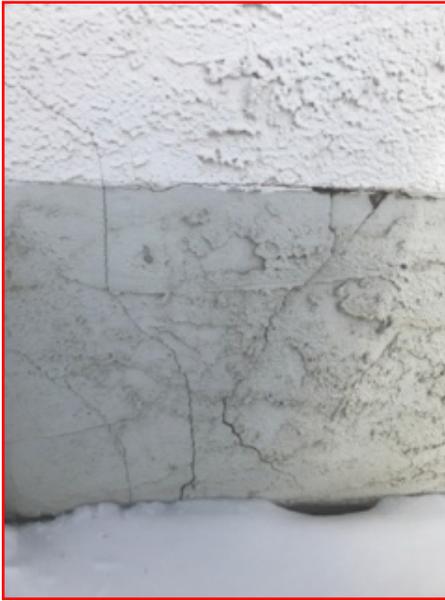
12) Comment 13: I have provided a sample of the cracks in the parging around the house; recommend repair of the parging to prevent moisture intrusion.

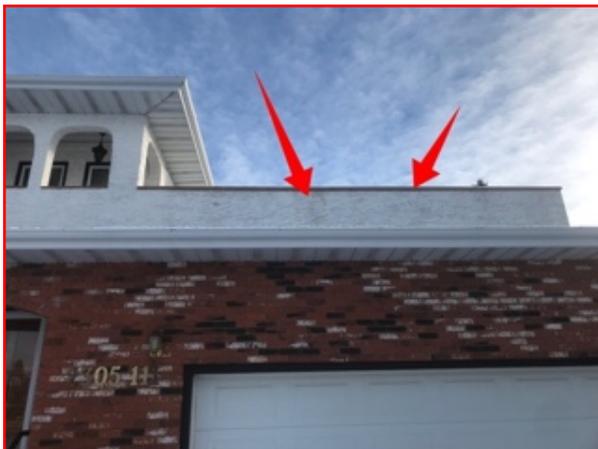
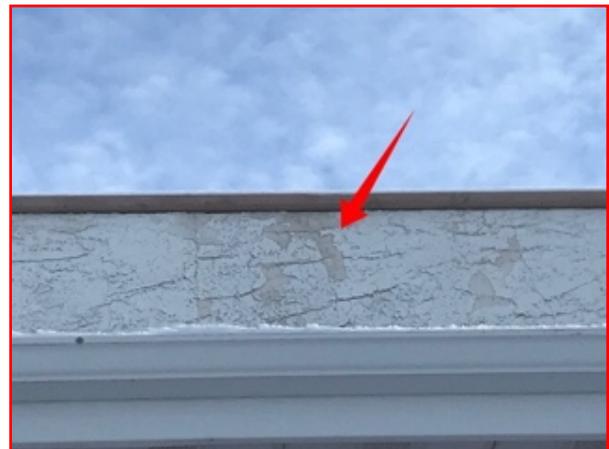
13) Comment 14: The stucco has been painted over at some point in time and there are areas around the house where the paint is starting to flake off. I have provided a sample image of what I am describing.

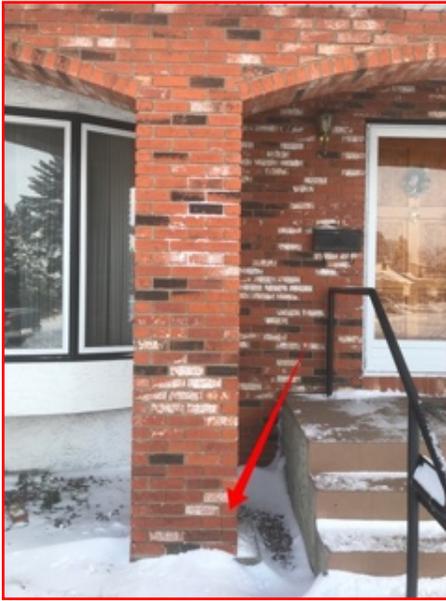
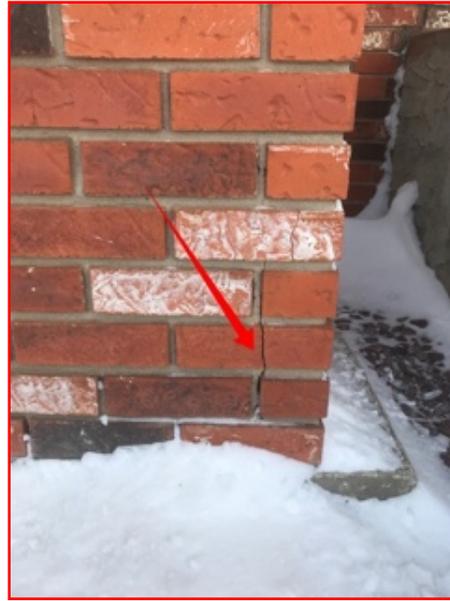
14) Comment 15: Minor separating the brick and mortar cracking on the pillar to the left of the front door; recommend repair to prevent further damage.

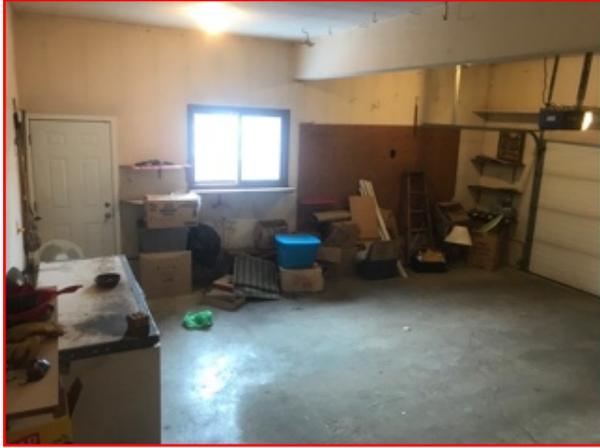
Figure 17-1

16) Comment 17: The garage smells heavily of cigarette smoke.

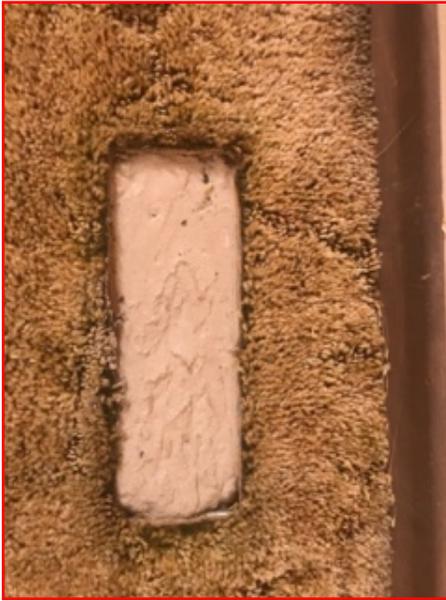
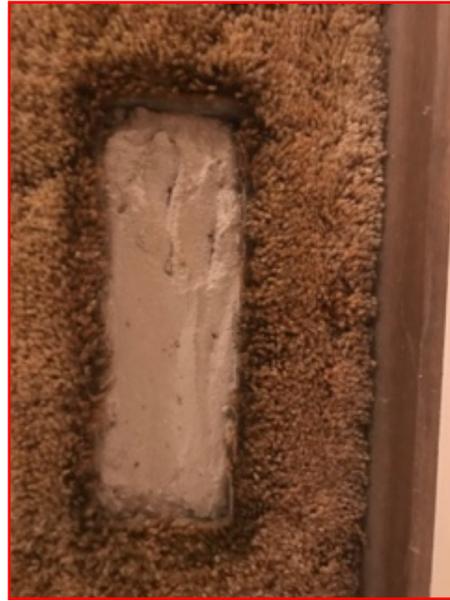
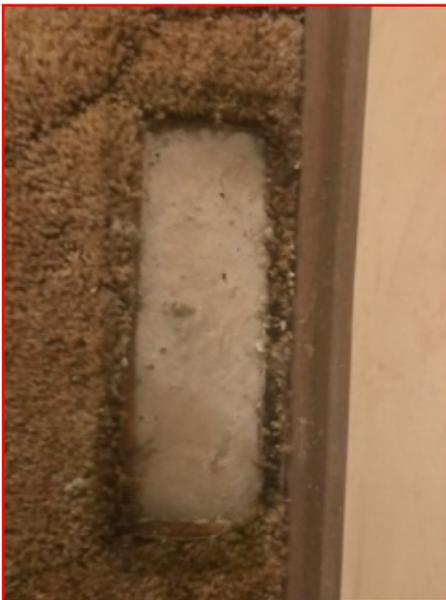
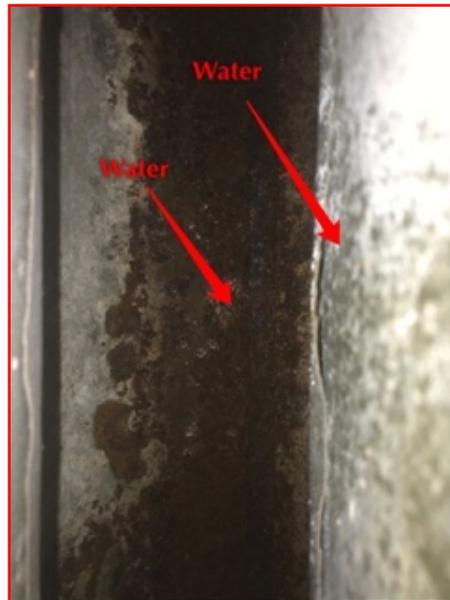
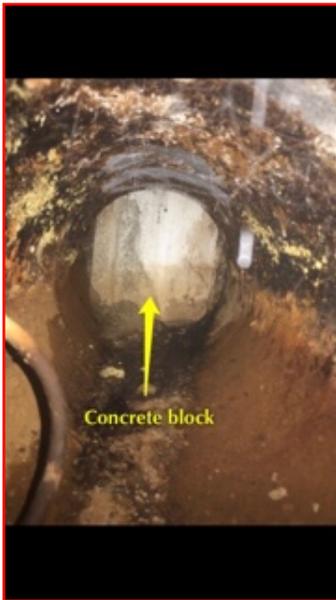
17) Comment 18: The in floor furnace ducting has been filled in with concrete except for one register. Upon inspection of the register there is rust in the bottom of it and active water (wet on my hand) present within the ducting. I believe there is a moisture problem under the slab as there is no weeping system. I believe that the water has infiltrated the ducting which is why they filled it in instead of installing a proper weeping system.

I have obtained images from within the old furnace cavity which shows the filled in concrete block and the fact that the flooring vents were 3/4 full of water at some point in time which has caused all of the rust seen in the images.

Recommend asking the home owner for more information.

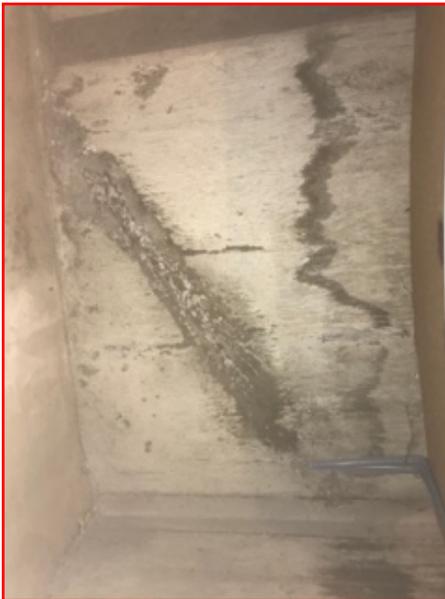
Figure 19-1

18) Comment 19: Signs of previous patch working being done. It is dry at this time.

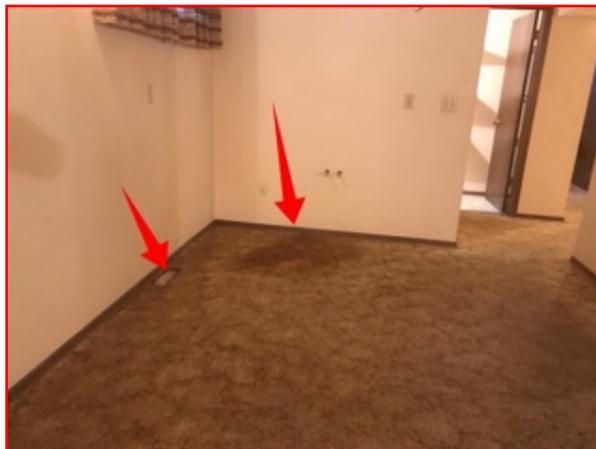
Figure 21-2

19) Comment 21: Staining throughout.

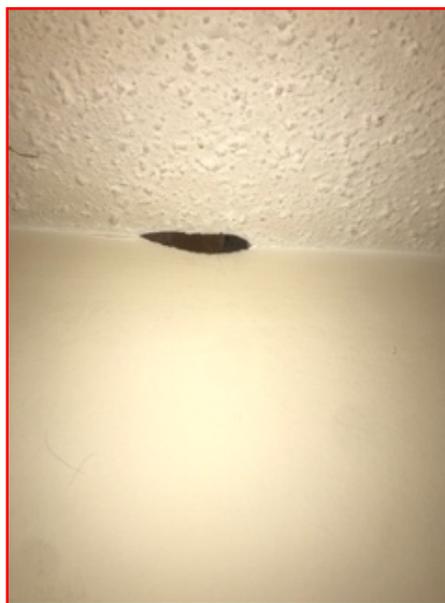
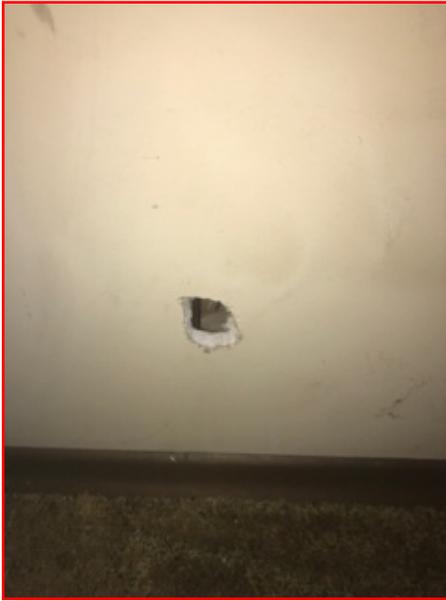
21) Comment 23: There are various areas throughout the basement where there are holes in the walls.

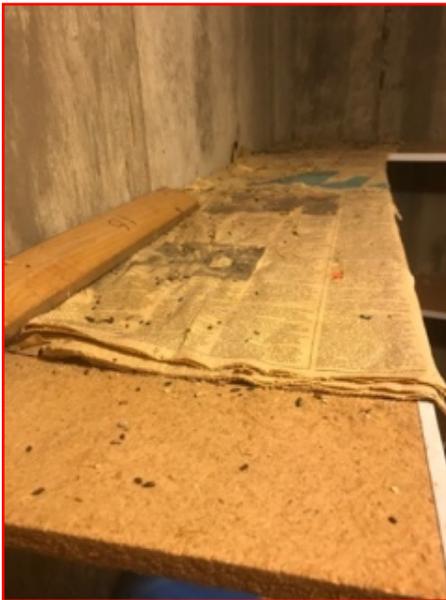
Figure 24-1

22) Comment 24: Signs of rodents.

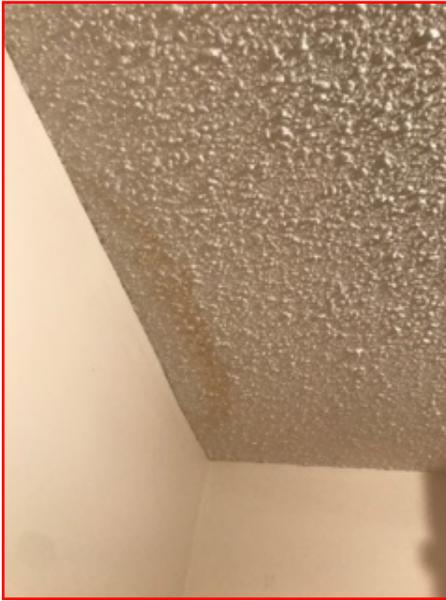
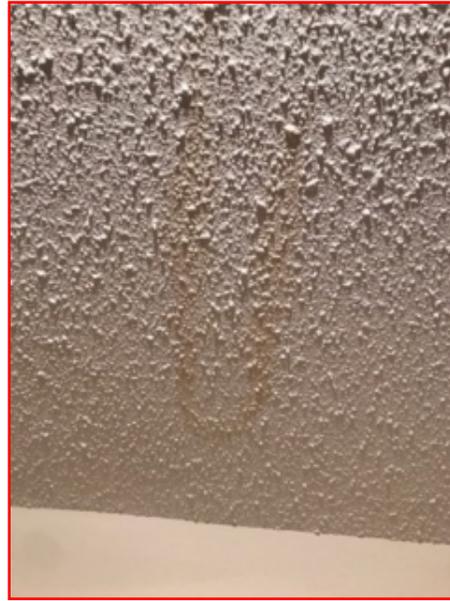
23) Comment 25: Unknown water staining in the ceiling of the electrical room. FLIR thermal camera didn't reveal any concerns.

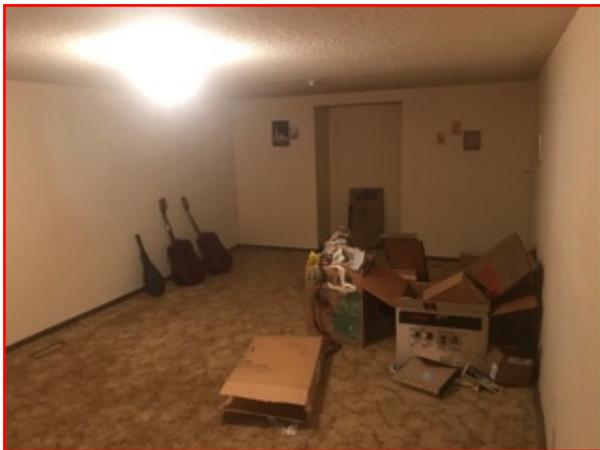
Figure 26-1

24) Comment 26: There is no heat in this room.

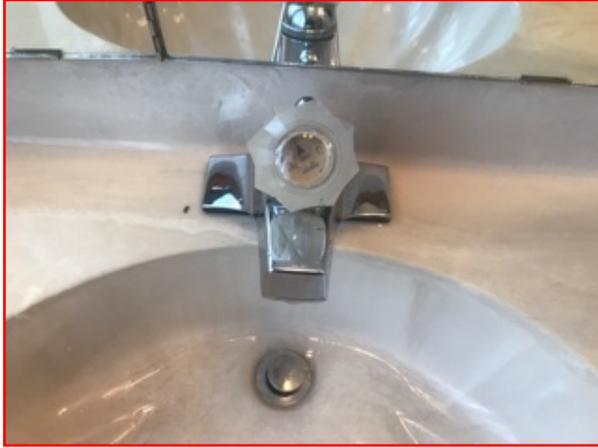
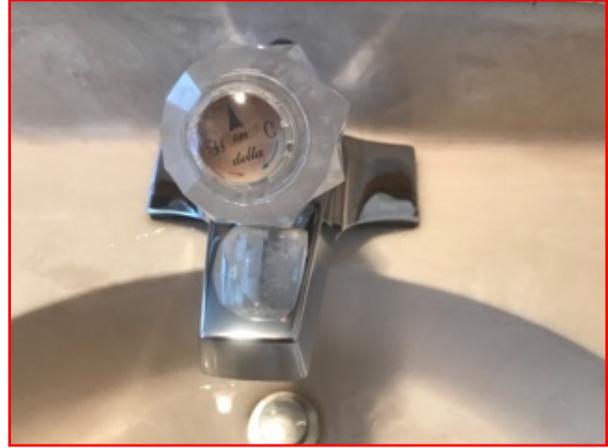
25) Comment 28: Both taps leak; recommend replacement.

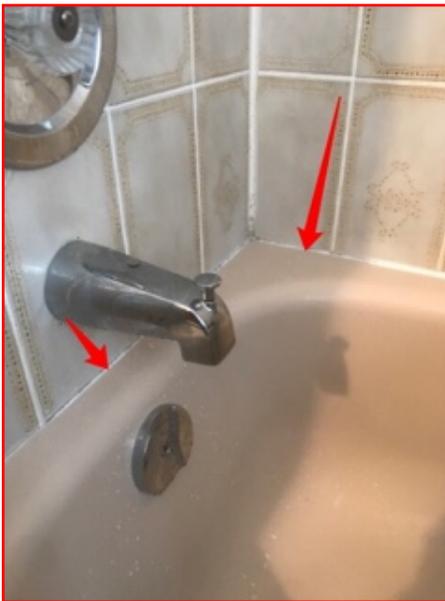
Figure 29-1

26) Comment 29: The caulking needs to be repaired to prevent moisture damage.

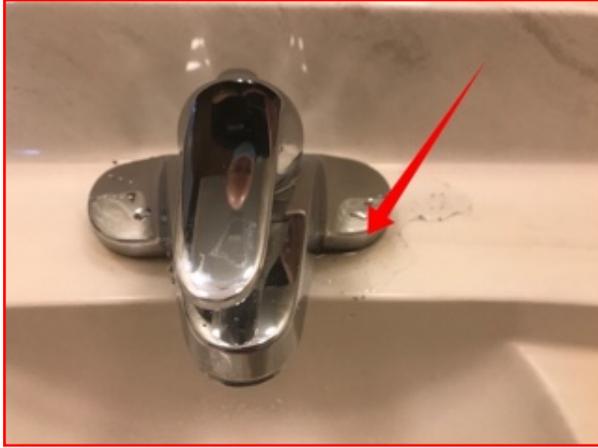
Figure 32-1

27) Comment 32: The tap is leaking; recommend replacement.

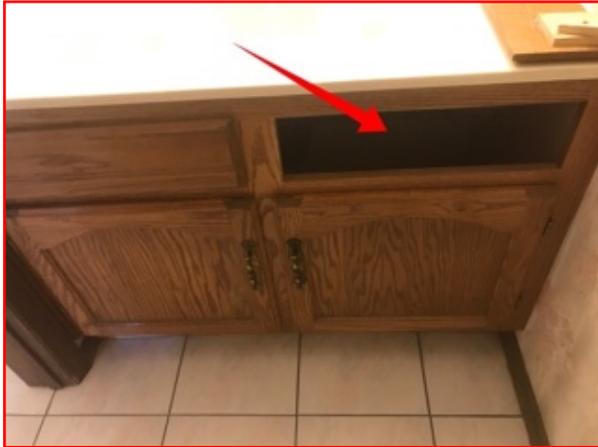
Figure 33-1

28) Comment 33: Broken vanity.

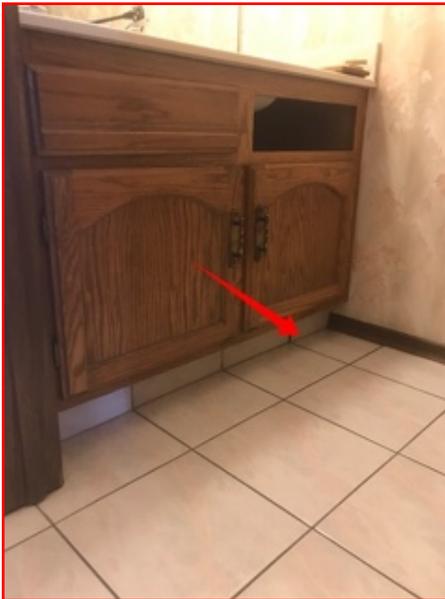
Figure 34-1

29) Comment 34: The tile is loose and coming off of the bottom of the cabinet.

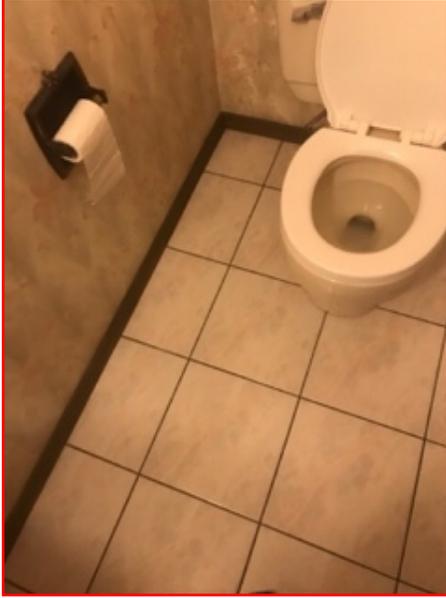
Figure 36-1

31) Comment 36: There is no heat source in the half bathroom and there should be; recommend repair.

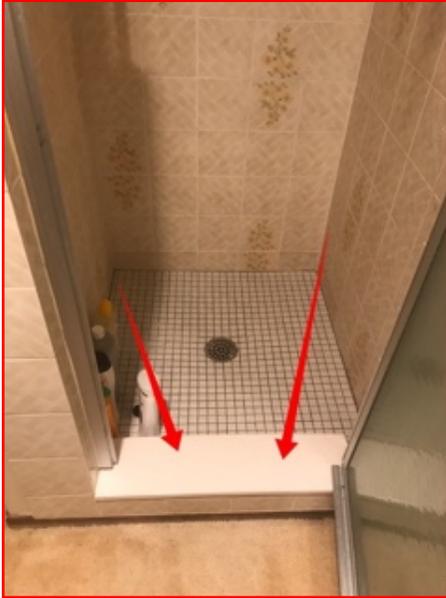
Figure 37-1

32) Comment 37: The shower threshold is loose and needs to be repaired.

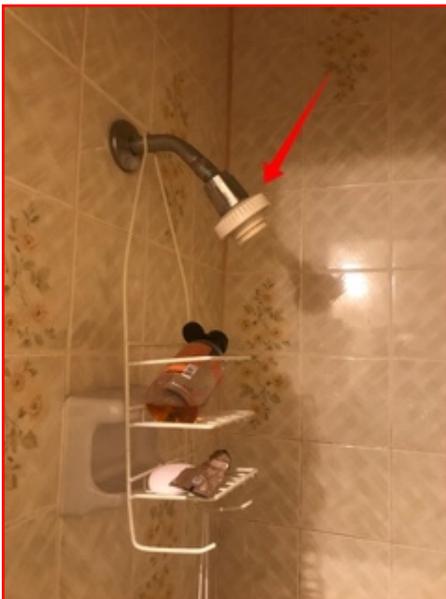
Figure 39-1

33) Comment 39: The shower head drips when not in use; recommend replacement.

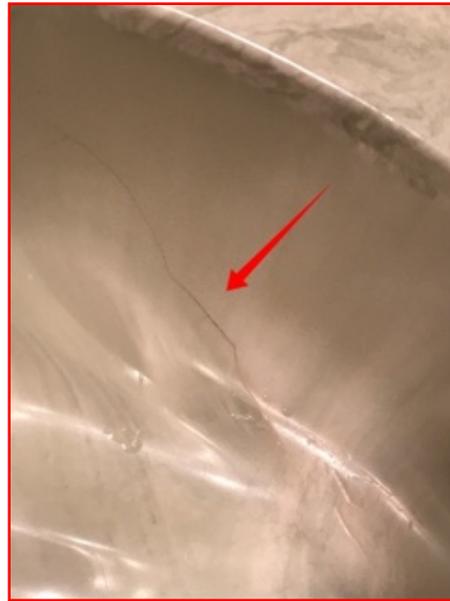
Figure 40-2

34) Comment 40: The sink is cracked and needs to be replaced.

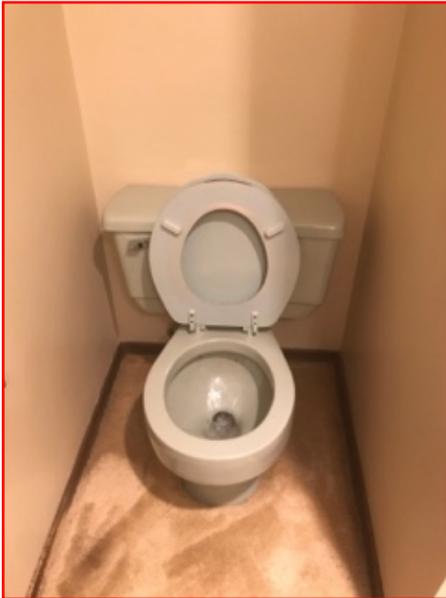
Figure 41-1

35) Comment 41: The toilet is loose and needs to be tightened.

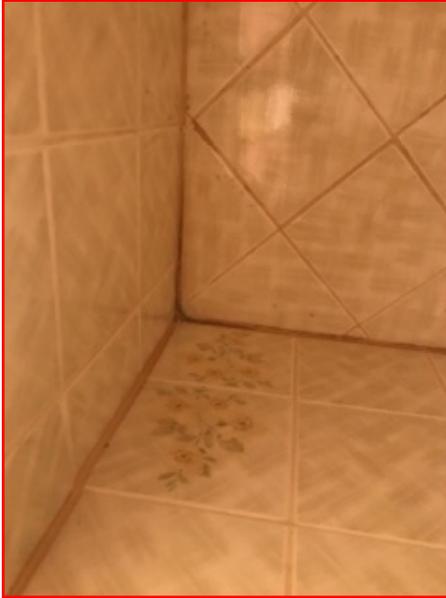
36) Comment 42: The caulking needs to be redone in the shower to prevent moisture damage. There is also visible mold growing on the caulking.

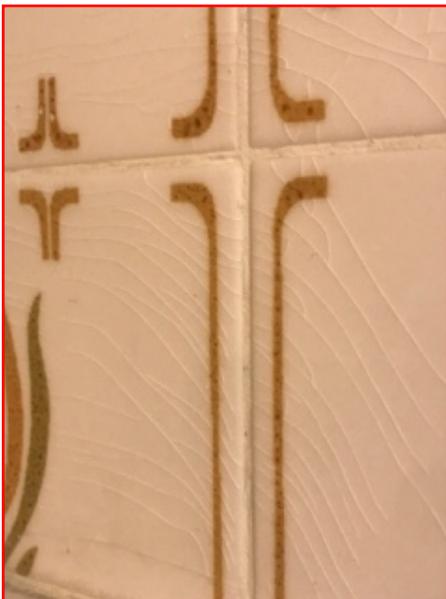
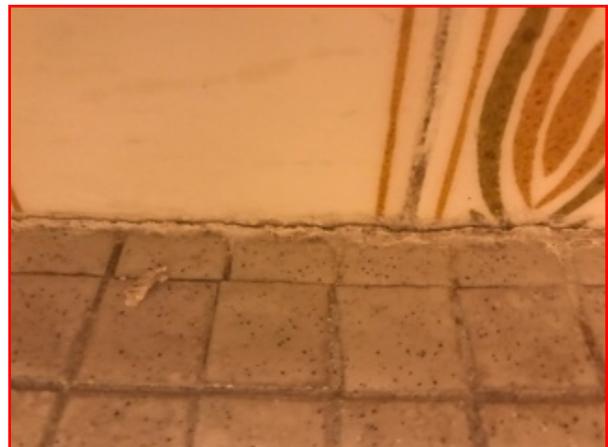
37) Comment 43: There are various tiles that are cracked and the shower base needs to be recaulked.

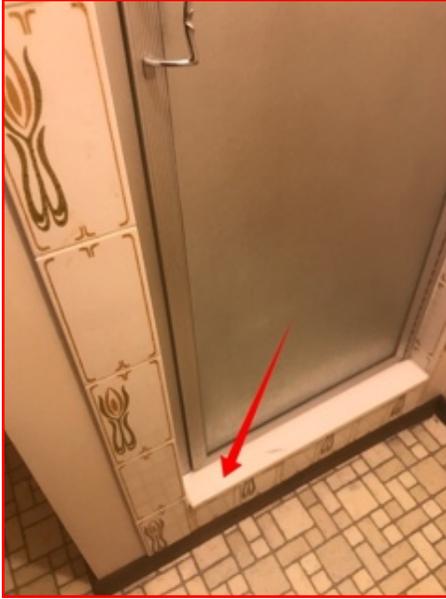
Figure 44-1

38) Comment 44: The shower door rubs on the sill plate.

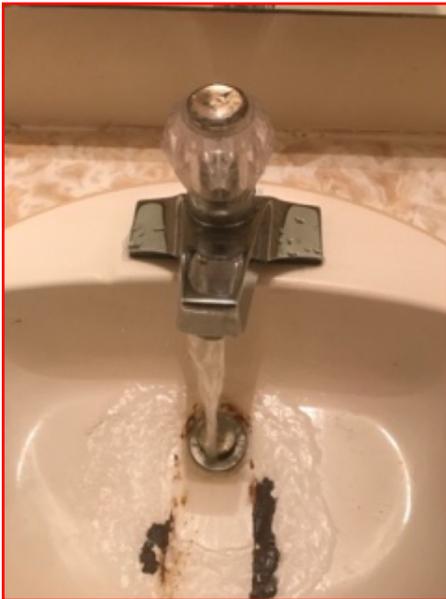
Figure 45-1

39) Comment 45: The tap leaks and the sinks porcelain is damaged.

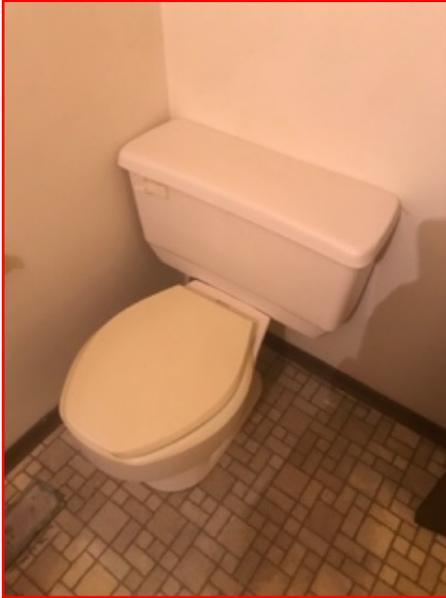
Figure 46-1

40) Comment 46: The toilet is loose and not connected to the floor.

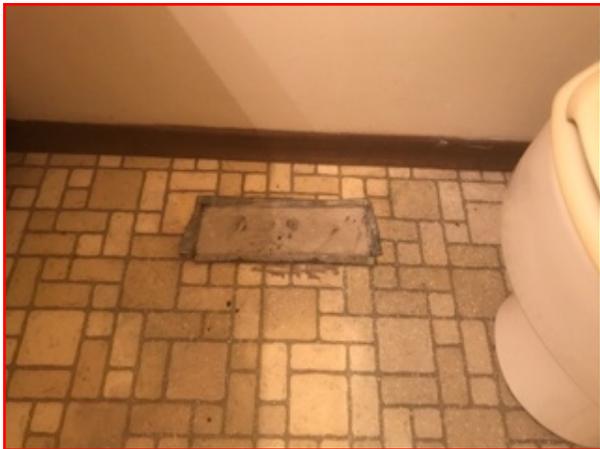
Figure 47-1

41) Comment 47: There is no heat source on the bathroom as the ducting has been filled in with cement.

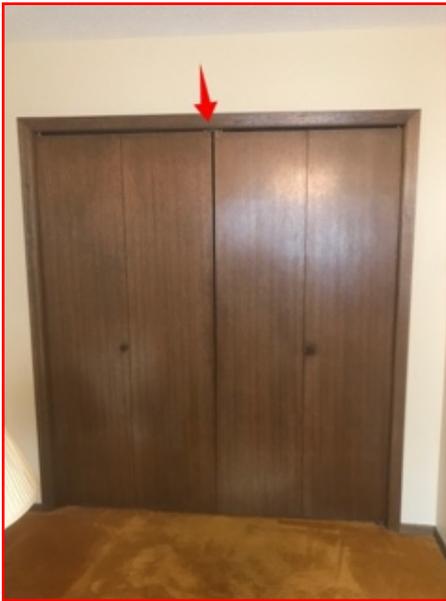
Figure 48-1

42) Comment 48: Broken mechanism and won't close properly.

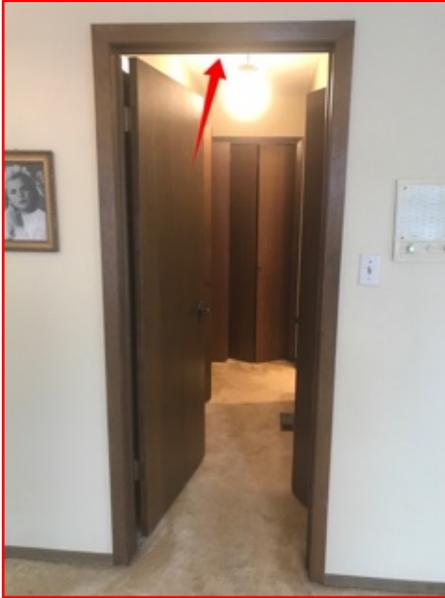
Figure 50-1

44) Comment 50: The door to the bathroom doesn't close properly as it binds on the top.

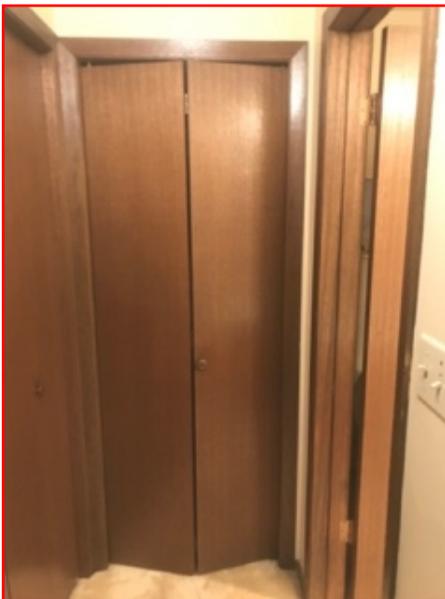
Figure 51-1

45) Comment 51: The bi-fold door in the closet doesn't close.

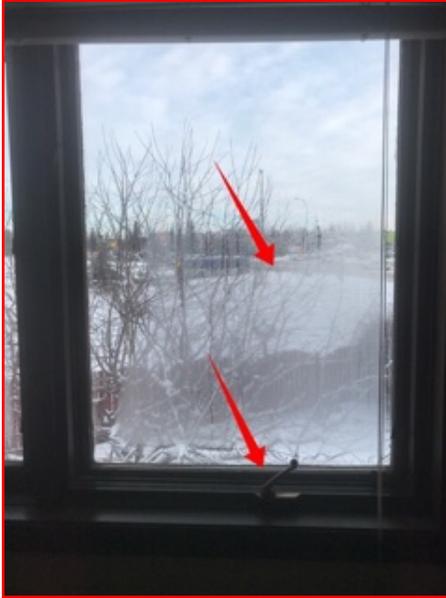
Figure 52-1

46) Comment 52: There is visible moisture on the windows and the window doesn't open and close properly; do not operate. There is a visible and Audible air gap.

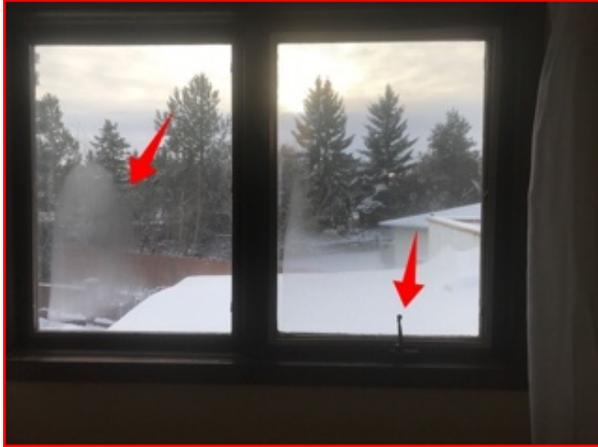
Figure 54-1

48) Comment 54: There is visible moisture on the window and a visible and audible air gap. The window mechanism is also broken and needs to be replaced. Do not open window.

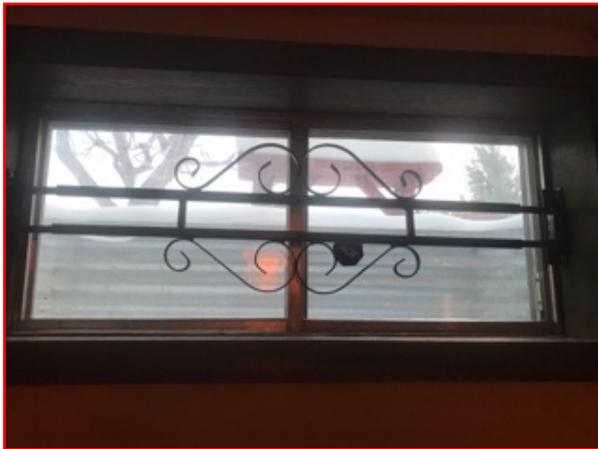
Figure 55-1

49) Comment 55: Won't open.

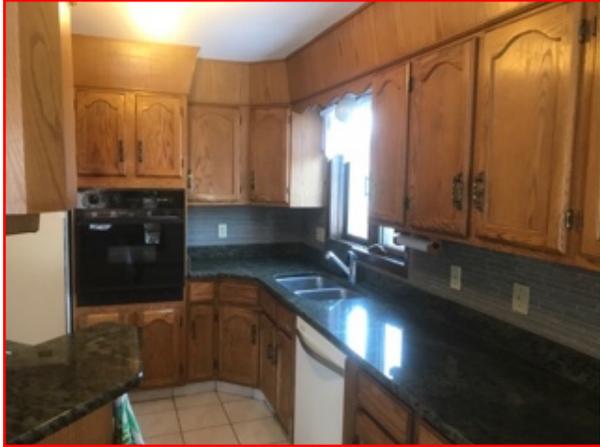
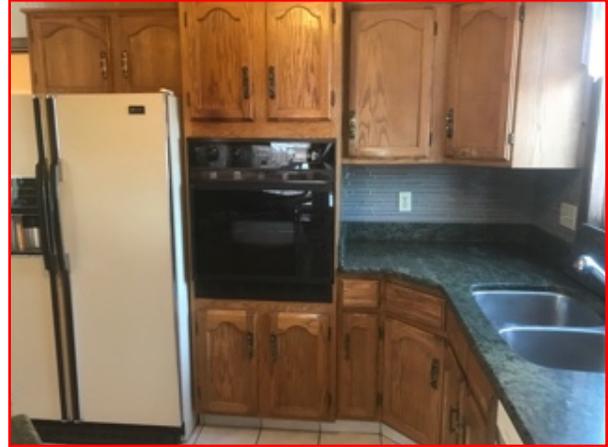
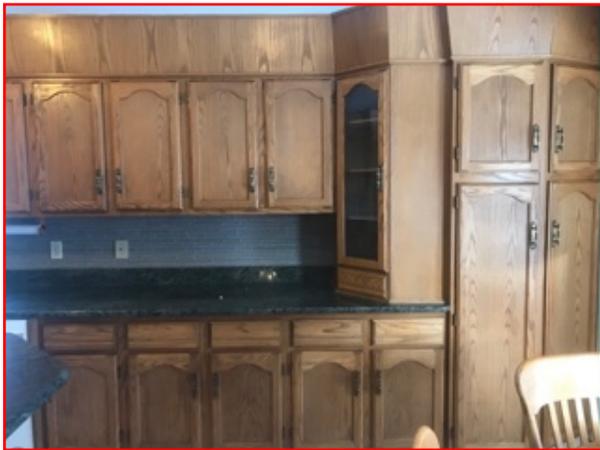
50) Comment 56: The cabinets are original to the home and show their wear and tear. The finish is coming off on some doors and drawers and the drawer slides are wearing out; recommend repair and replacement of items needed.

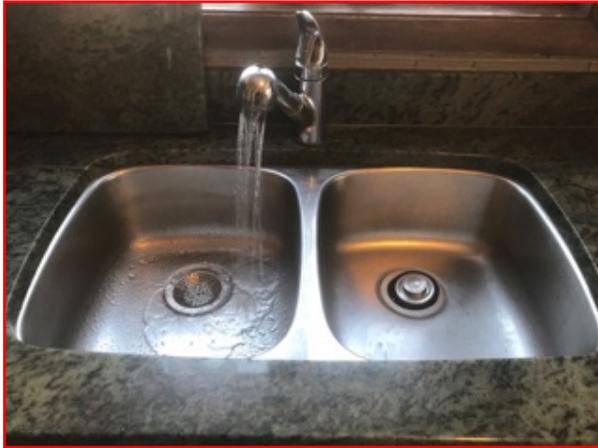
Figure 57-1

51) Comment 57: Very weak water pressure and the tap can't be switched between spray and constant flow; recommend replacement of faucet.

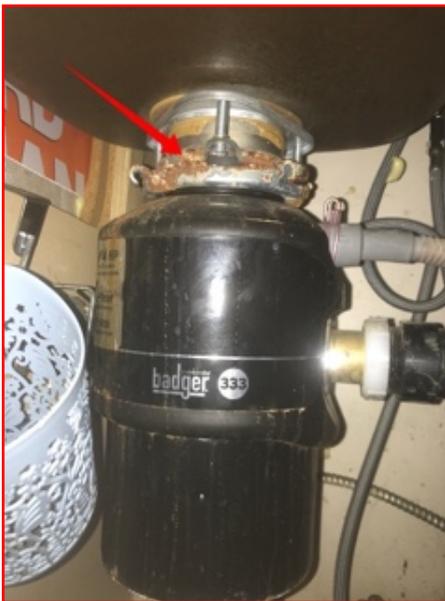
Figure 58-1

52) Comment 58: There is excessive rust on the top mount of the garbage disposal which suggests that there is a leak at some point in time.

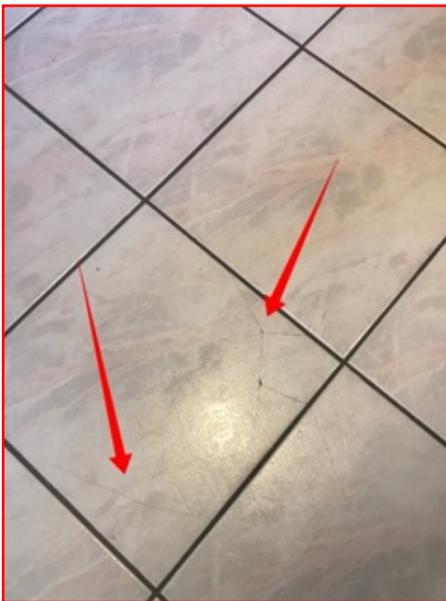
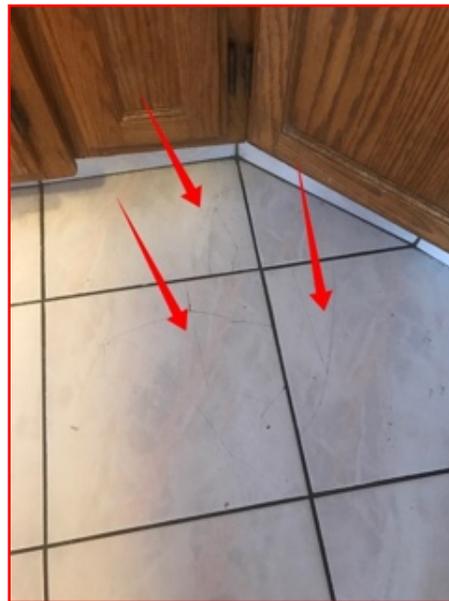
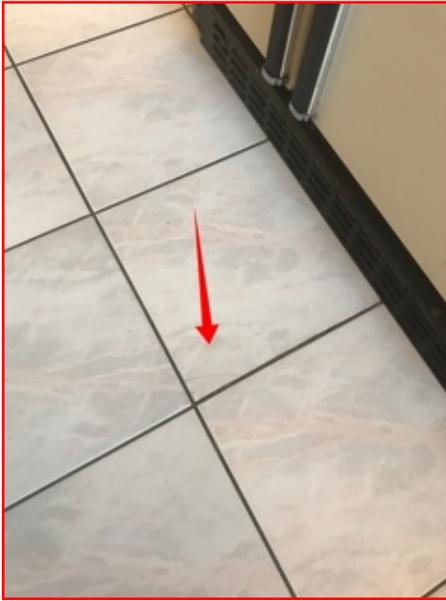
54) Comment 61: There are cracked tiles throughout the kitchen; recommend replacement.

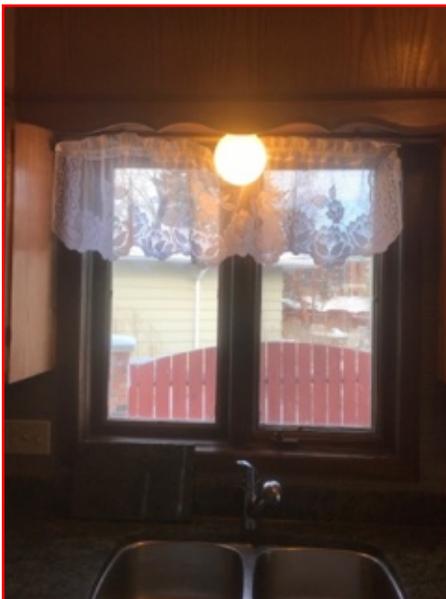
Figure 62-1

55) Comment 62: The kitchen window does not open and close smoothly; recommend repair or replacement.

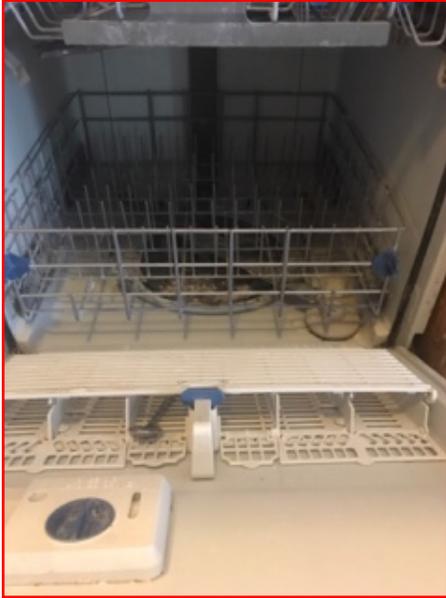
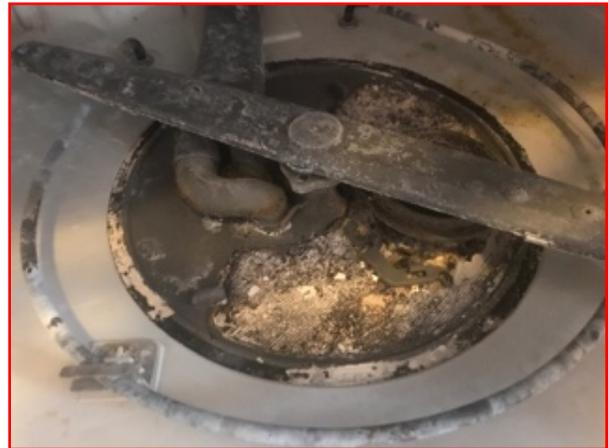
58) Comment 68: The dishwasher works at the time of inspection but it is very dirty, smells and needs to be cleaned.

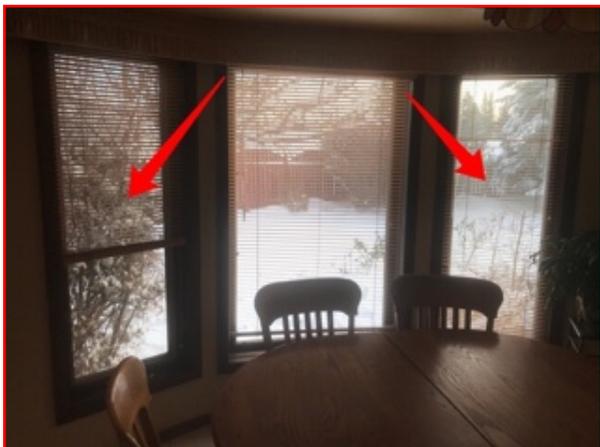
Figure 69-1

59) Comment 69: The left window doesn't open due to overgrowth and the right window is very hard to open and close; recommend replacement.

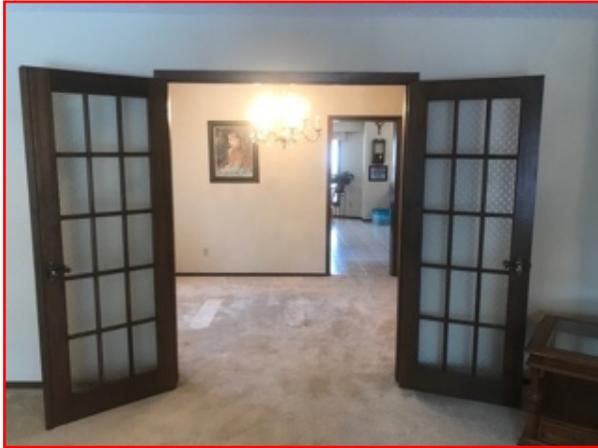
Figure 70-1

60) Comment 70: This set of doors doesn't close properly due to warped doors and thick carpet; recommend repair.

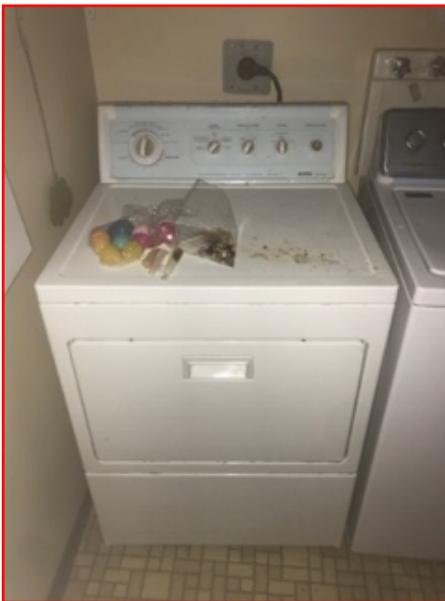
Figure 71-1

61) Comment 71: There is a hum to the motor which suggests that it isn't balance; recommend repair.

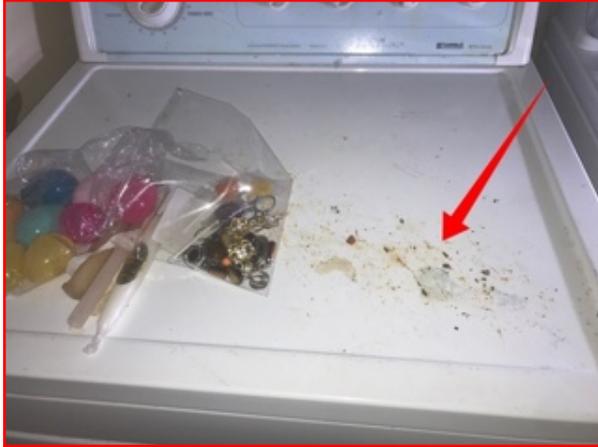
Figure 72-1

62) Comment 72: Rust and damaged top.

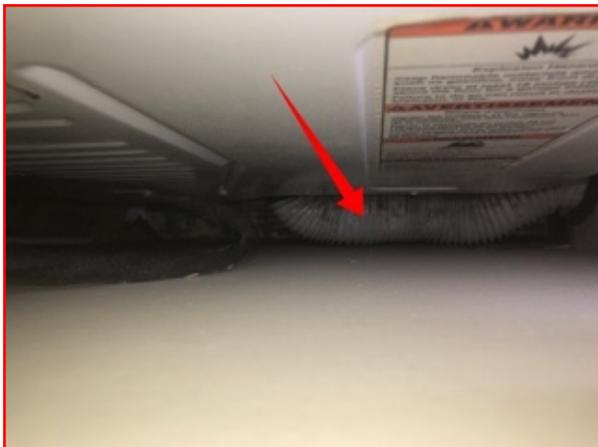
Figure 73-1

63) Comment 73: The dryer vent is an expandable flex hose which causes build up of lint in the ripples of the hose; this is a safety concern. Recommend a general contractor or HVAC mechanic replace the expandable flex hose with a straight pipe.

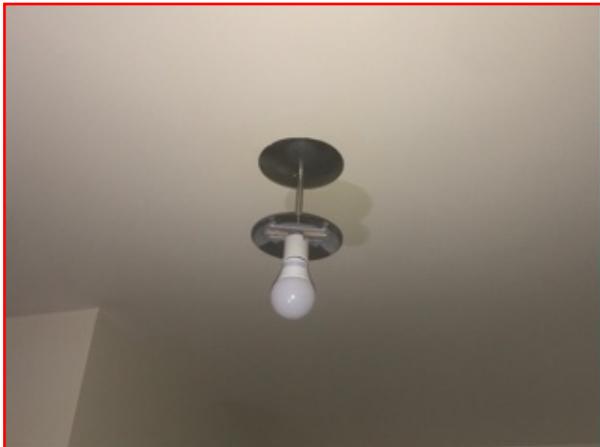
Figure 74-1

64) Comment 74: The light is either burnt out or not working.

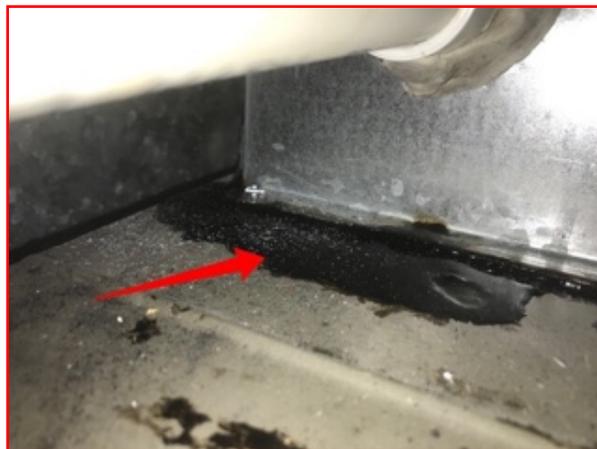
Figure 80-2

66) Comment 80: Unknown black oil tar leaking from inside the furnace ducting; recommend having a licensed HVAC contract assess the unit to figure out where it is coming from. It is believed that the AC coil is leaking oil.

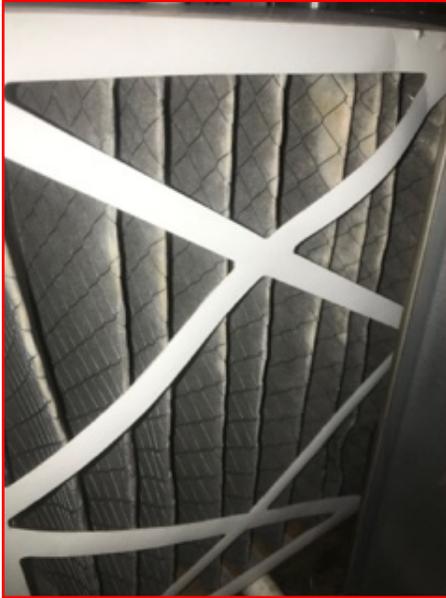
Figure 81-1

67) Comment 81: Filter needs to be replaced.
