# Brown's Home Inspections Ltd. (License # 352839)

## Home Inspection Report

**Edmonton, AB**

Inspected on Wed, Nov 17 2021 at 1:30 PM

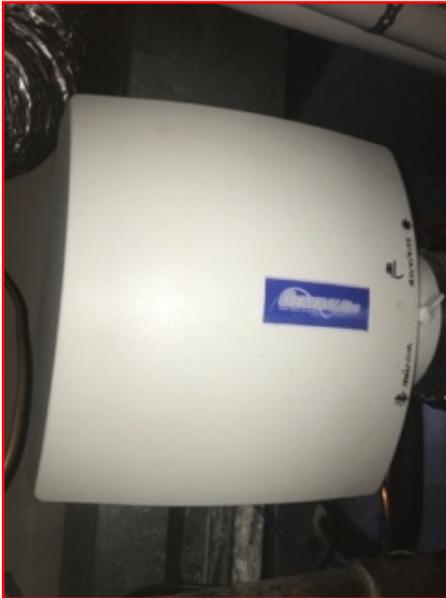
Figure 82-1

68) Comment 82: There was no water flowing to the humidifier during operation.

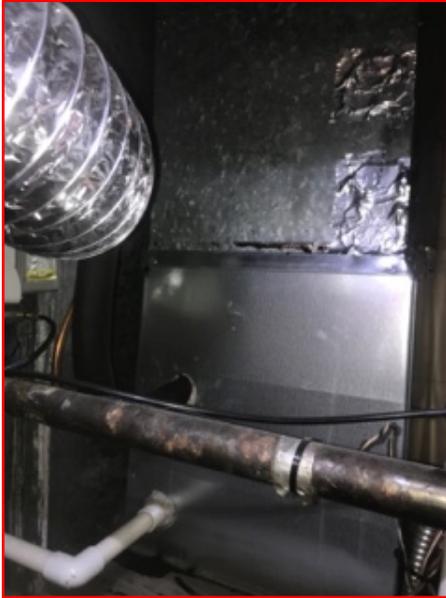
Figure 84-1

69) Comment 84: No data plate sticker was visible.

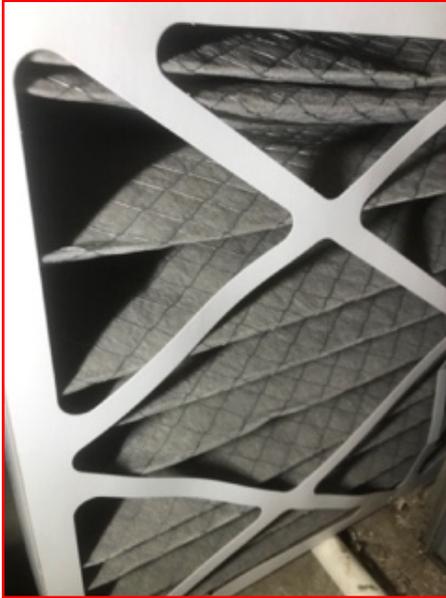
Figure 86-1

71) Comment 86: The filter needs to be replaced.

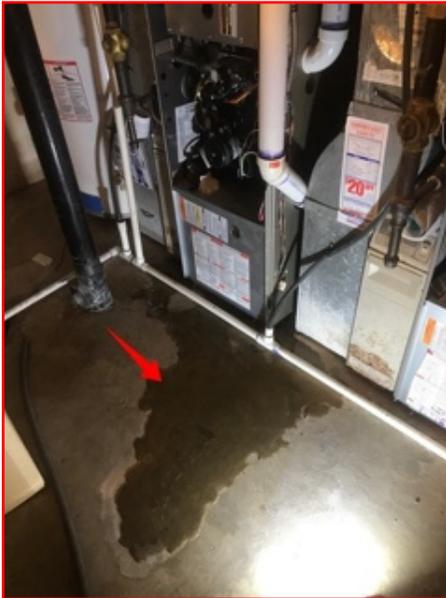
Figure 87-1

72) Comment 87: There is an active water leak; recommend repair.

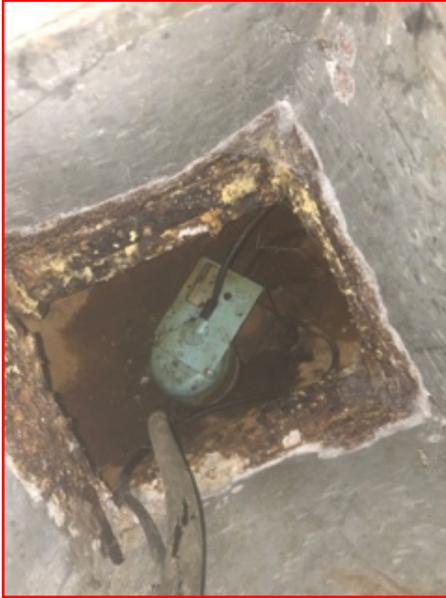
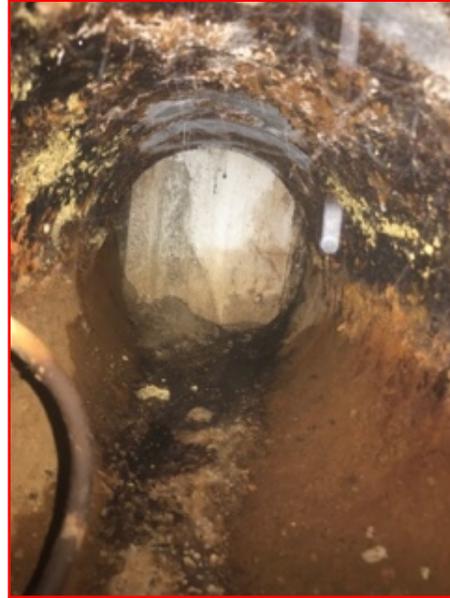
73) Comment 90: There is a sump pump placed inside of the old furnace venting to pump out the excess water.

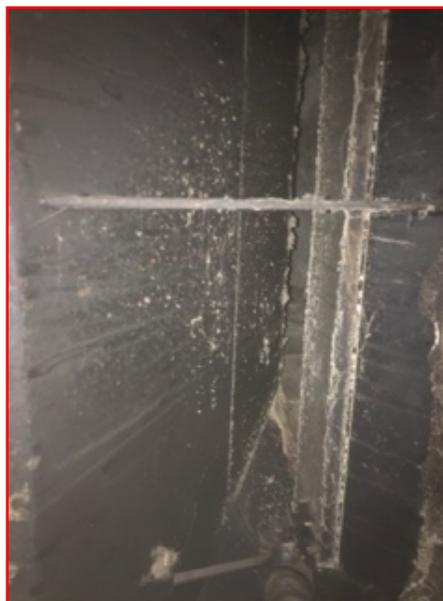
74) Comment 94: The fireplace looks lightly used. The gas assist has been disconnected and the flue on the inside isn't working properly and won't close properly high is sucking all of the interior heat up and out the chimney (this can be seen in the FLIR image which was obtained showing the cold cavity). Recommend a WETT certified inspection and repair.

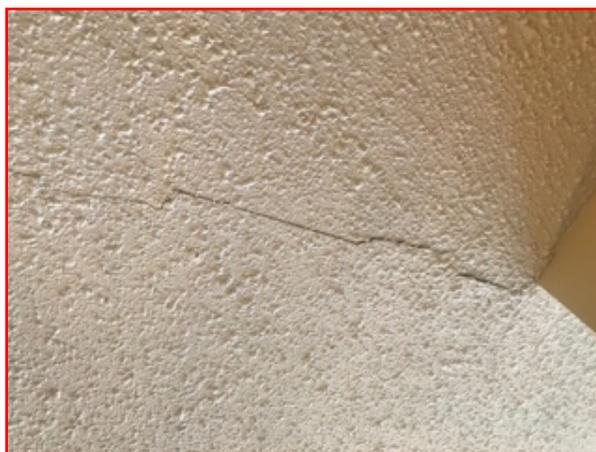
Figure 96-2

76) Comment 96: There is a visible crack and separating in the ceiling to the hallway on the second floor; recommend repair.
